SUBJECT : INVESTIGATION REPORT ON THE ALLEGED DUMPING OF
AGGREGATES ALONG CAGURAY RIVER, BARANGAY
PURNAGA, MUNICIPALITY OF MAGSAYSAY,
OCCIDENTAL MINDORO

SUBJECT : INVESTIGATION REPORT ON THE ALLEGED DUMPING OF
AGGREGATES ALONG CAGURAY RIVER, BARANGAY
PURNAGA, MUNICIPALITY OF MAGSAYSAY, OCCIDENTAL
MINDORO

ANNEX A – Photo Documentation

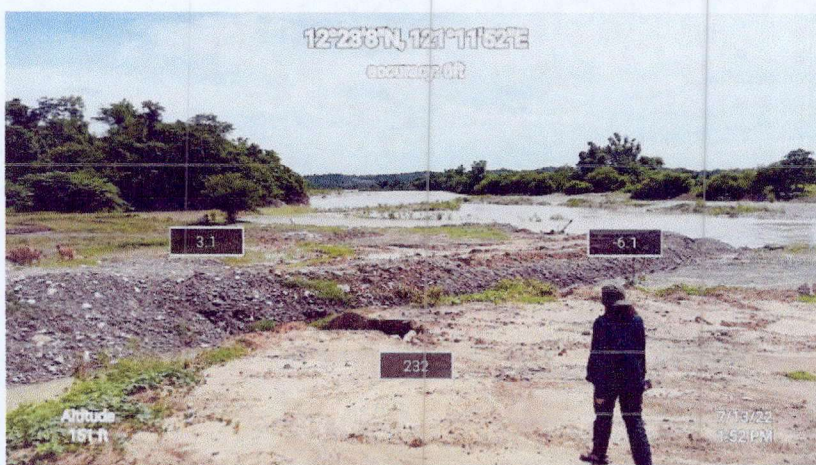
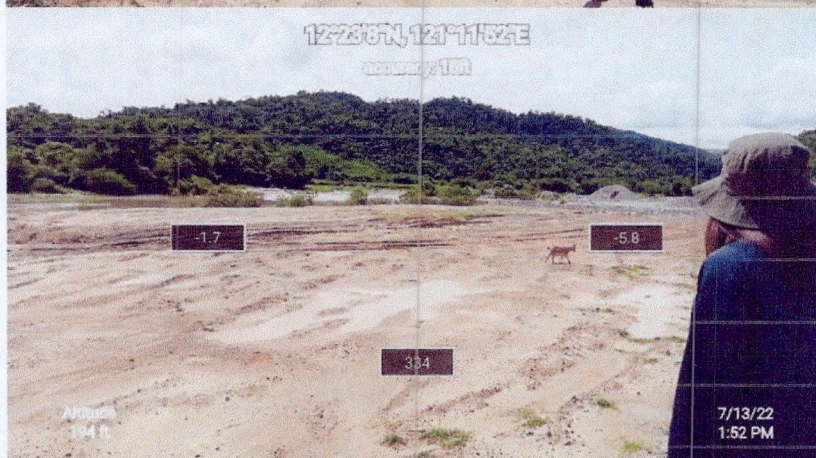
4. The following were observed during the site inspection:
- The aggregates were dumped along the riverbank of Caguray River and not within its active channel. (See Photos A-2-3)

Photo 2. The extent of the dumped yellowish to brownish colored aggregates along a section of the Caguray riverbank near Barangay Purnaga.

2. To reiterate, the aggregates were dumped along the existing riverbank of Caguray River and not within its channel. Rivers naturally divert their course mainly driven by the combination of bank erosion and point bar deposition over time. Significant changes to the channel flow may not occur as long as the current state of the river and its banks are not disturbed (i.e., no stockpiling or dumping of aggregates *within* the active river course, and intentional extraction of aggregates along the riverbanks).

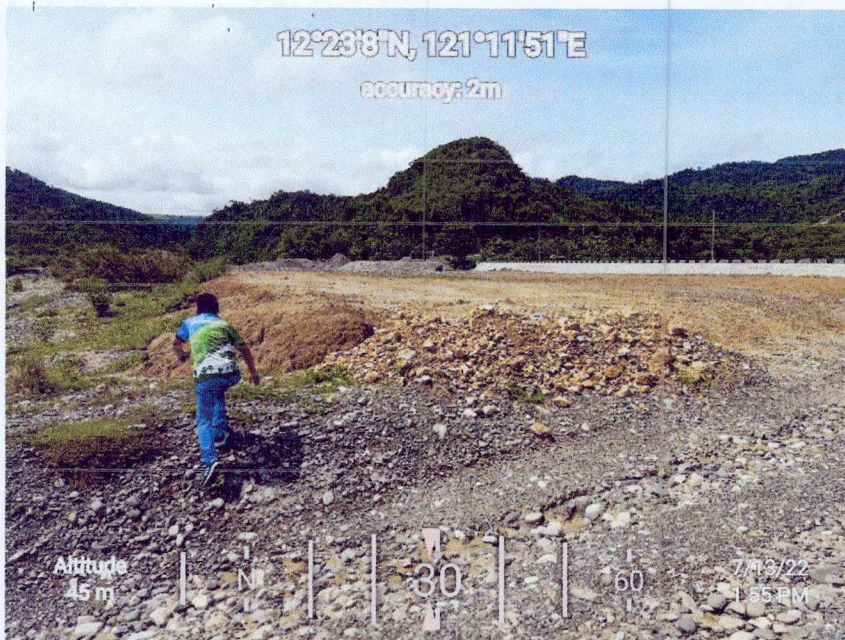
- The point bar of this segment of the river is situated near the riverbank adjacent to the low-lying areas of Brgy. Paclolo, which is heavily silted with pebble to cobble deposits. On the contrary, the riverbank on the side of Barangay Purnaga, where the dumped aggregates are located, is being continuously eroded by the river. (See Photo A-4)

Photo 3. The extent of the dumped yellowish to brownish colored aggregates along a section of the Caguray riverbank near Barangay Purnaga.

Erosion takes place at the cut bank along Barangay Purnaga adjacent to the subject area. As a result, scouring of riverbank in the barangay is expected to continue. On the contrary, the heavily silted point bar and river flow direction are to the areas covered by Barangay Paclolo, resulting in a relatively shallow channel that is prone to extensive river overflows/flooding, particularly during rainy season. In addition, the barangay is located at a relatively lower elevation than Purnaga, making it more vulnerable to flooding events.

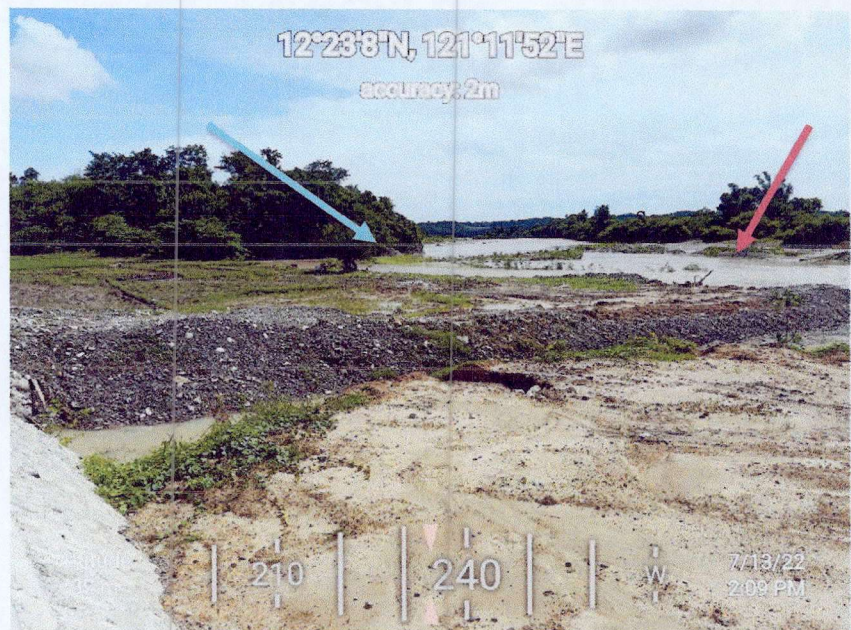
Photo 4. The point bar (arrow in red) portion of the river segment and its cut bank (in blue) located on the sides of Barangays Paclolo and Purnaga, respectively. The photo also shows the portion of the riverbank that is being utilized for planting crops and pasture for animals.

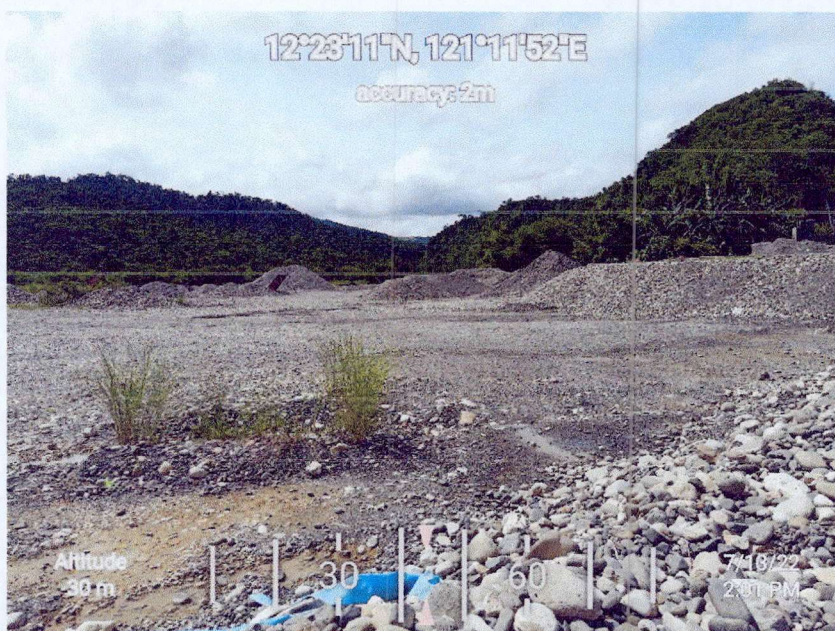
5. Previously a rice field, portions of the said riverbank are now utilized by river quarry operators to stockpile sand and gravel deposits. Some of these stockpiles were noted during the site assessment (See Photo A-5). According to the locals, some of these

Photo 5. Observed stockpiles of sand and gravel located on the riverbank's northern portion.

4. Likewise, both the LGUs of Barangays Paclolo and Purnaga should prohibit quarry operators from stockpiling extracted river deposits within the river channel. Moreover, additional vegetation in critical riverbank slopes and floodplain areas can be

introduced to augment appropriate protection measures for potential flood and erosion hazards.
