SUBJECT : **1ST QUARTER REPORT ON THE CONDUCTED
BIODIVERSITY ASSESSMENT AND MONITORING SYSTEM
(BAMS) FOR MALAMPAYA SOUND PROTECTED
LANDSCAPE AND SEASCAPE (MSPLS), TAYTAY-SAN
VICENTE, PALAWAN FOR CY 2023**

SUBJECT : **1ST QUARTER REPORT ON THE CONDUCTED BIODIVERSITY ASSESSMENT AND MONITORING SYSTEM (BAMS) FOR MALAMPAYA SOUND PROTECTED LANDSCAPE AND SEASCAPE (MSPLS), TAYTAY-SAN VICENTE, PALAWAN.**

Dry Season of First Quarter CY 2023

WATER QUALITY MONITORING
FIELD DATA FORM

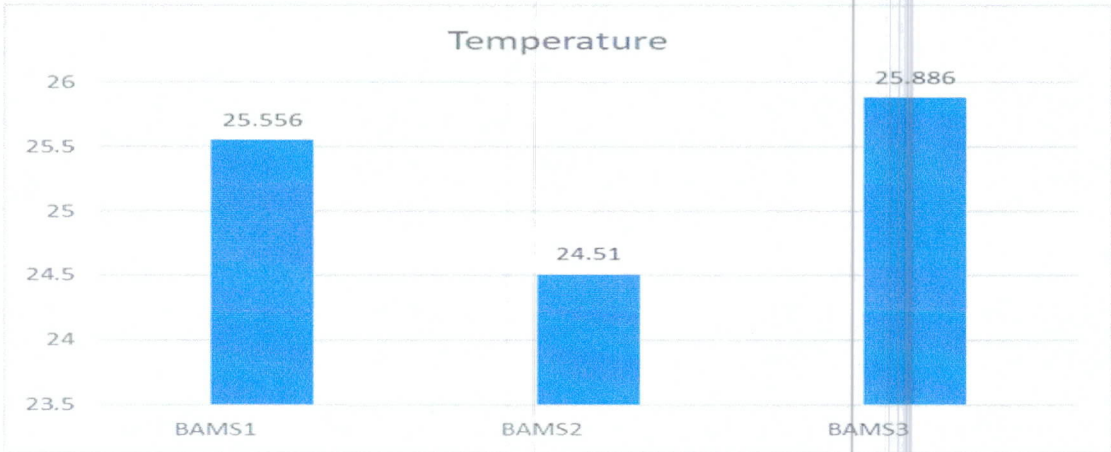
Figure II. Temperature of three (3) stations.

SITE	TEMPERATURE	Remarks (Class AA Criteria,26-30 Celsius)
BAMS1	25.556	Fail
BAMS2	24.51	Fail
BAMS3	25.886	Fail

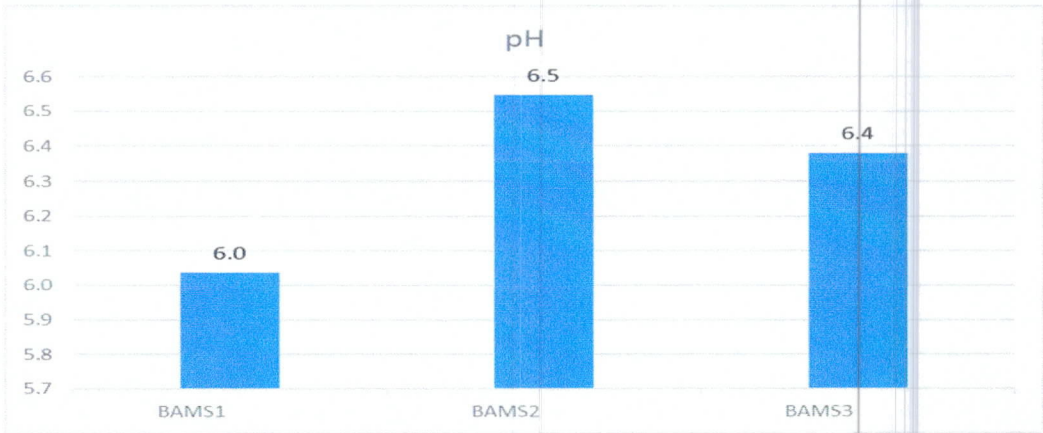
Figure III. pH of three (3) stations.

SITE	PH	Remarks (Class AA Criteria, 6.5 - 8.5")
BAMS1	6.0	Fail
BAMS2	6.5	Pass
BAMS3	6.4	Fail

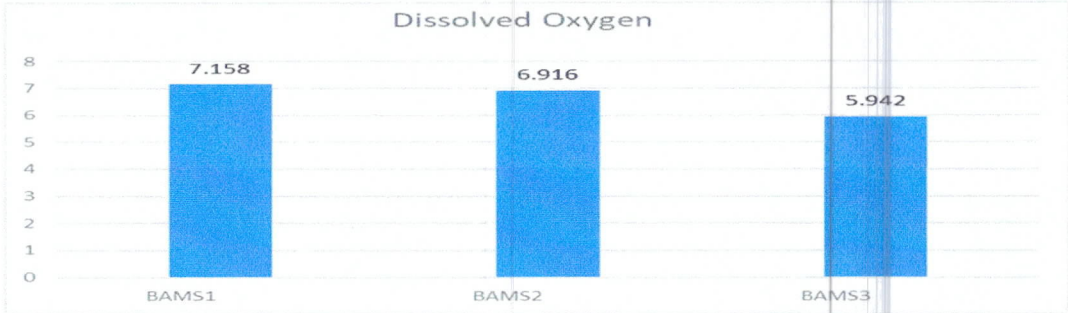
Figure IV. Dissolved Oxygen of three (3) stations.

SITE	DISSOLVED OXYGEN	Remarks (Class AA Criteria, Minimum 5)
BAMS1	7.158	Pass
BAMS2	6.916	Pass
BAMS3	5.942	Pass

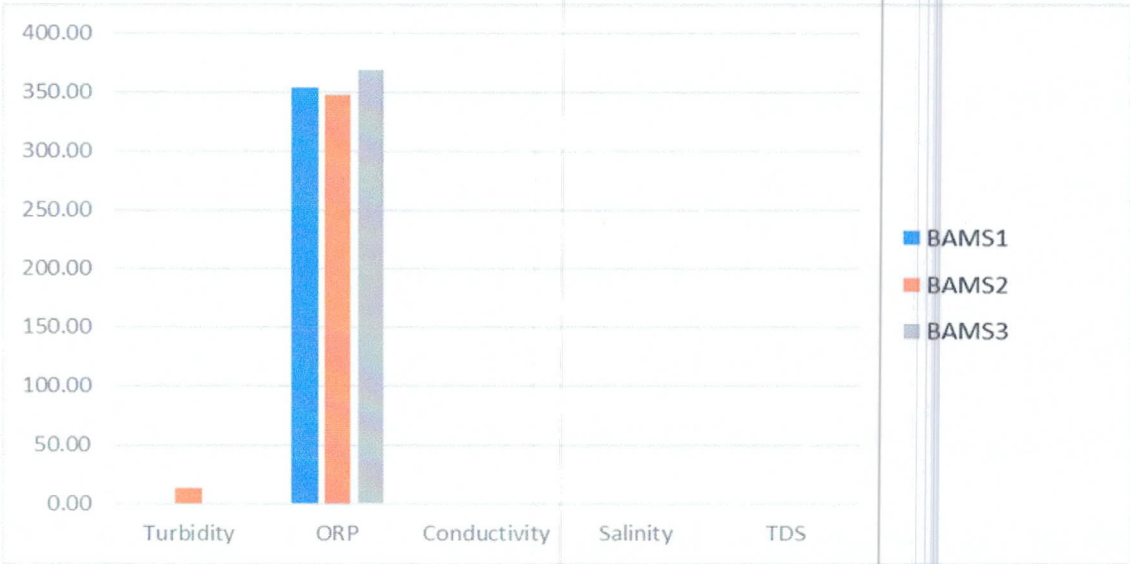
Figure V. Comparison of three (3) stations.

SITE	TURBIDITY	ORP	CONDUCTIVITY	SALINITY	TDS
BAMS1	0.00	354.60	0.11	0.05	0.07
BAMS2	13.62	347.40	0.06	0.03	0.04
BAMS3	0.00	369.00	0.07	0.03	0.04

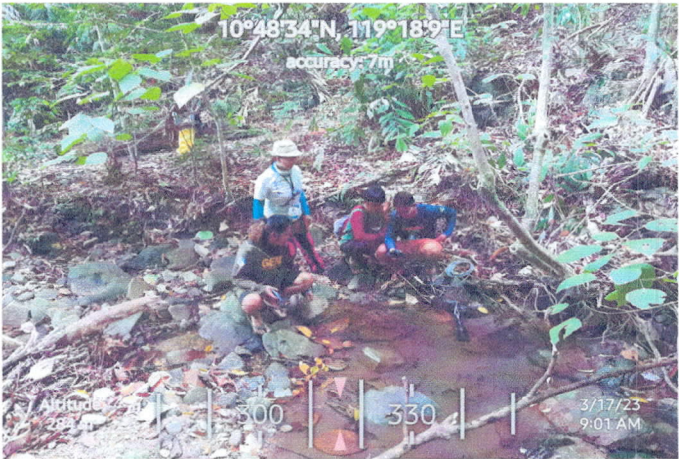
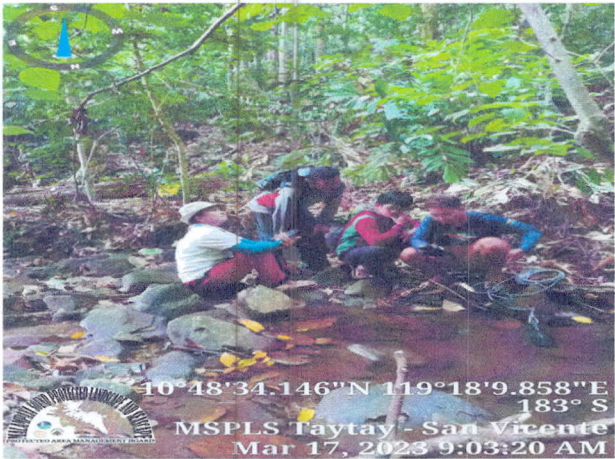
The team during the 1st station Water Quality Monitoring at BAMS Area Barangay Banbanan, Taytay, Palawan.

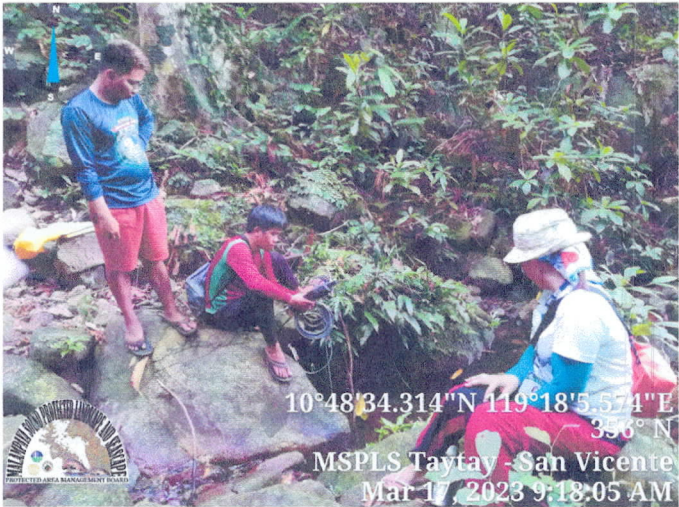
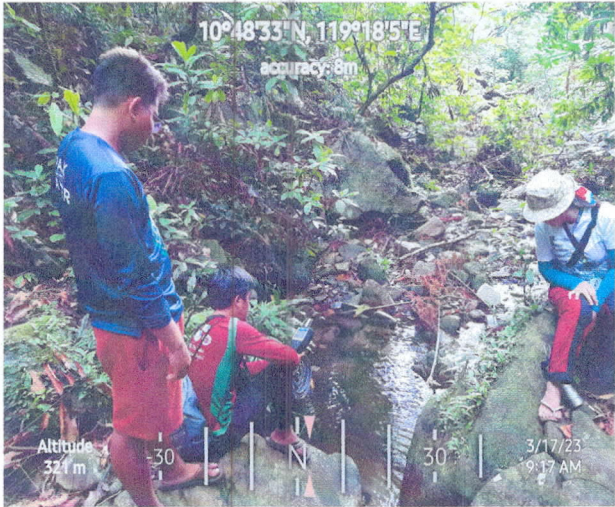
The team during the 2nd station Water Quality Monitoring at BAMS Area Barangay Banbanan, Taytay, Palawan.

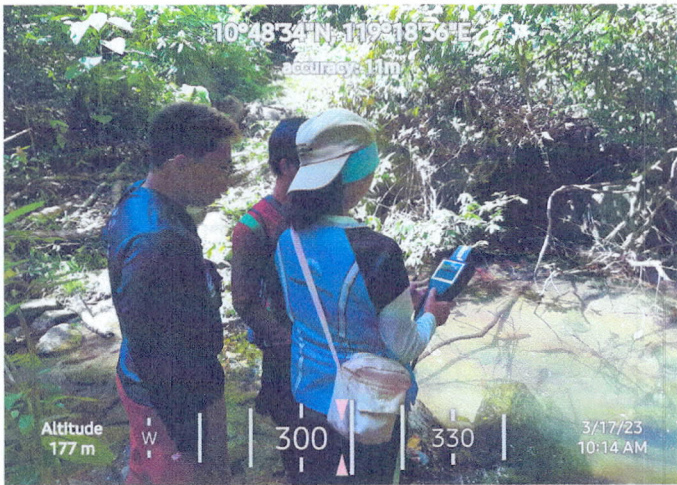
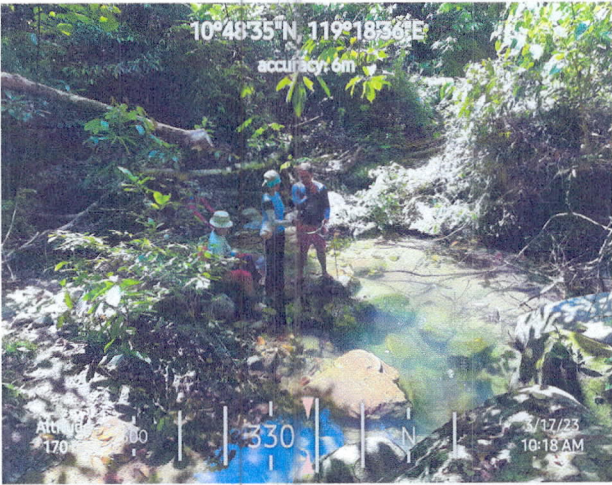
The team during the 3rd station Water Quality Monitoring at BAMS Area Barangay Banbanan, Taytay, Palawan.
