**SUBJECT** : **SUBMISSION OF PROGRESS REPORT ON THE ACTIVITIES  
FOR THE WATERSHED CHARACTERIZATION AND  
VULNERABILITY ASSESSMENT OF ALAG-BACO WATERSHED  
FOR THE 2<sup>ND</sup> QUARTER OF CY2023**

**GEO-TAG PICTURES TAKEN DURING THE CONDUCT ON THE ACTIVITIES  
FOR WATERSHED CHARACTERIZATION WITH VULNERABILITY  
ASSESSMENT OF ALAG BACO WATERSHED**

**ALAG-BACO RIVER WATERSHED CHARACTERIZATION  
REPORT**

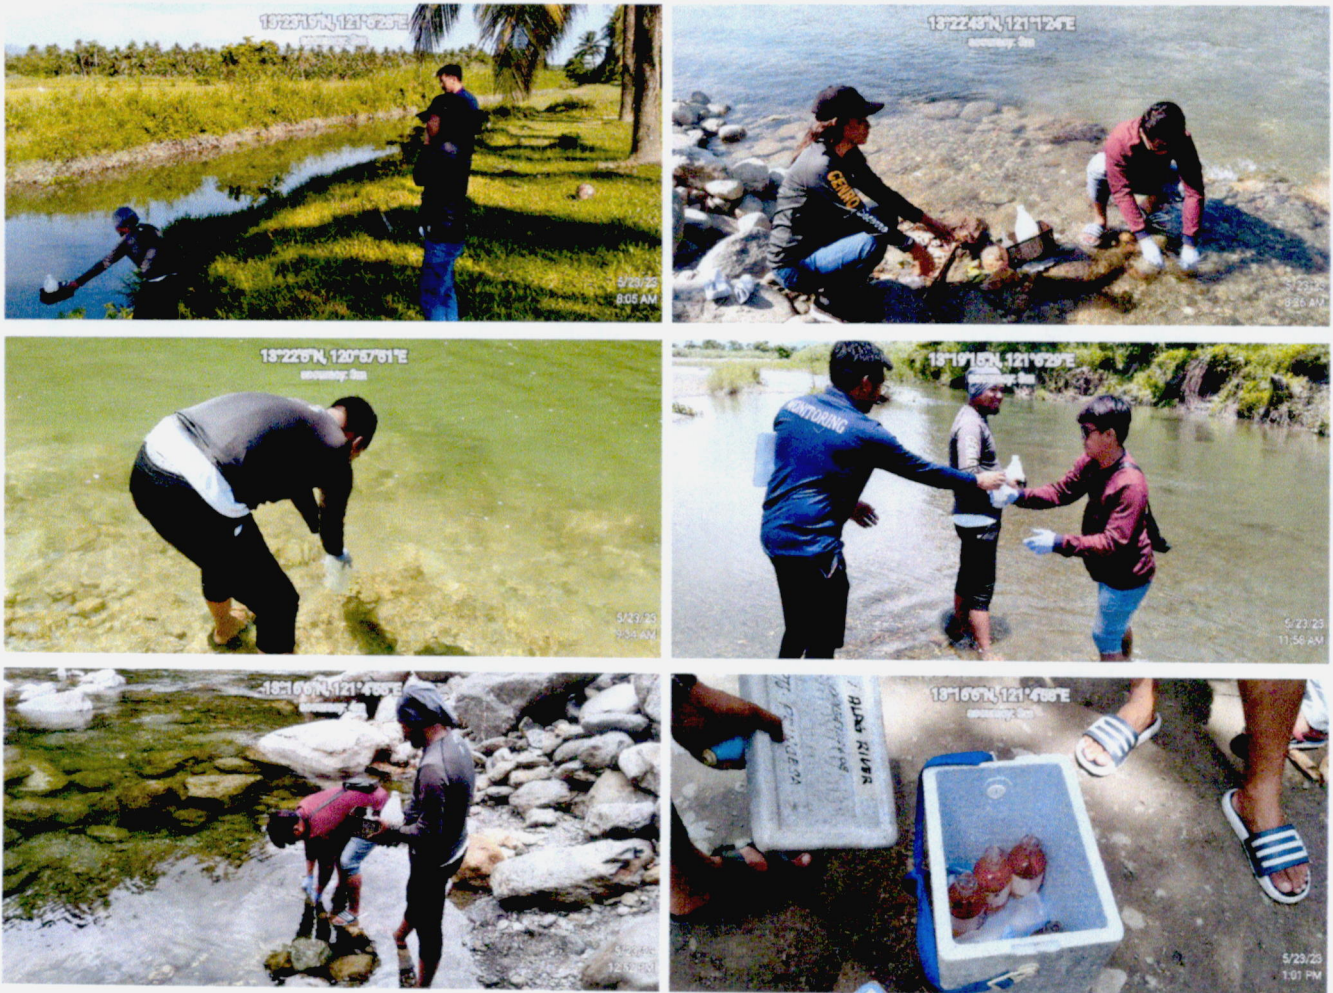
Figure 3: Conducted water sampling collection in different sampling site in the watershed area.

Primary data collection such as soil and water samples from different strategic location of the watershed comprising the upstream, midstream and downstream areas. Soil permeability and bulk density were measure using the equipment from the Regional Office while the water samples were brought to the EMB-MIMAROPA Oriental Mindoro Satellite Office in Calapan City.

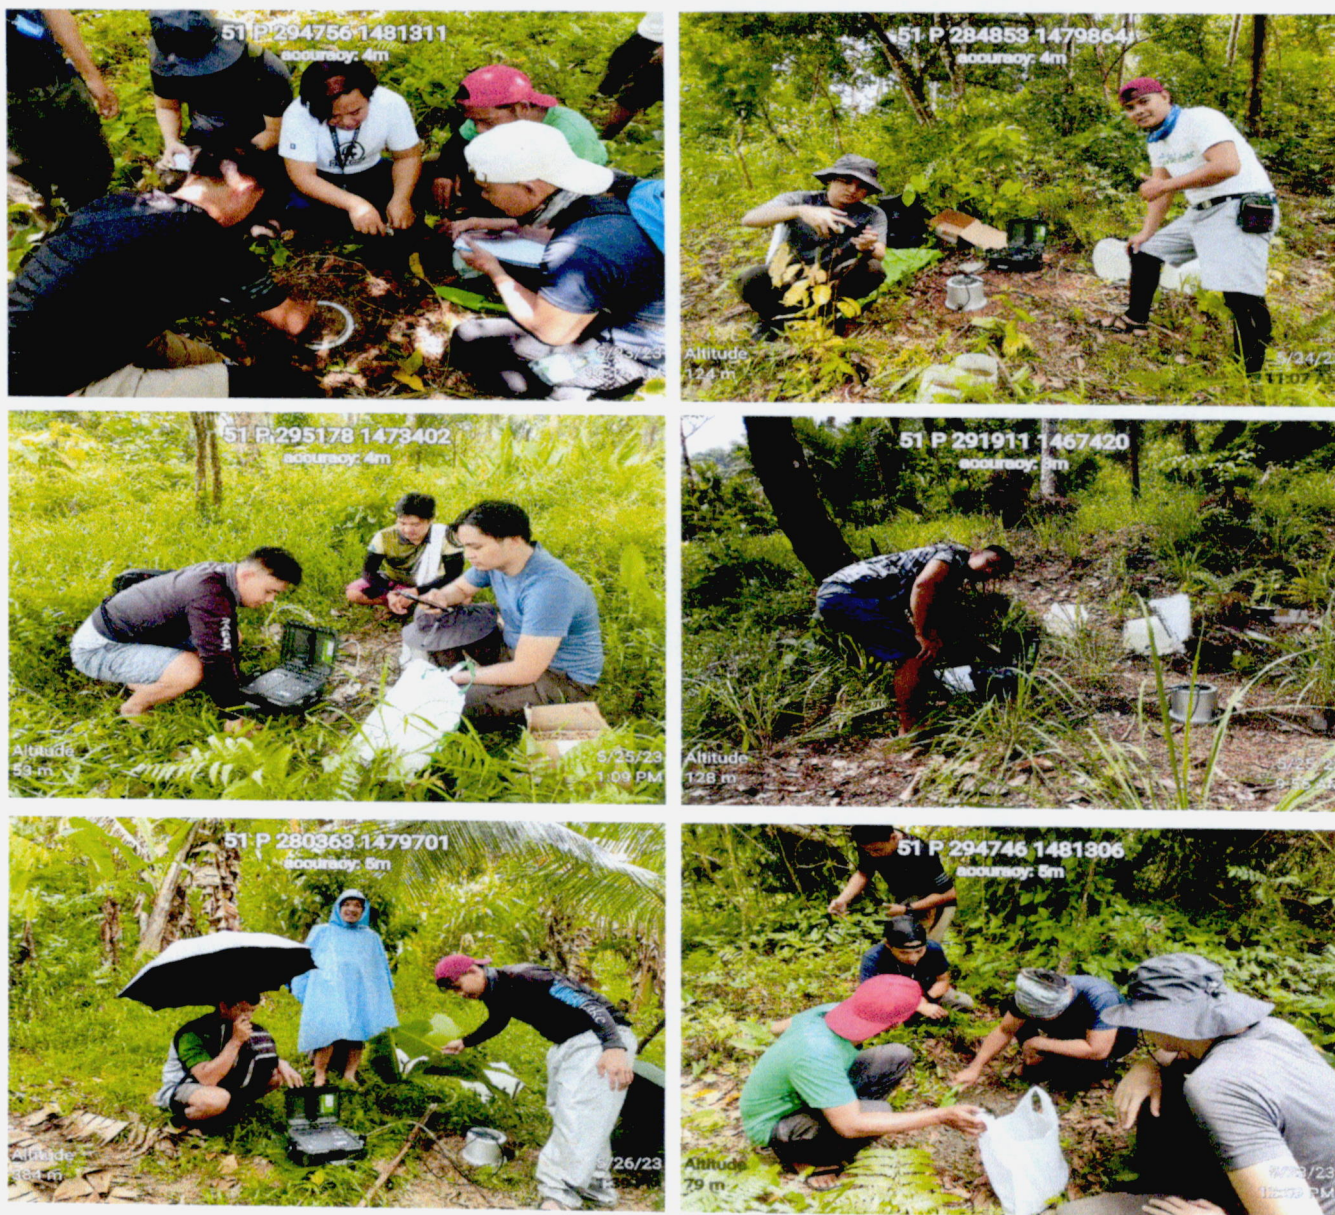
**Figure 3: Conducted soil collection for soil analysis, bulk density and soil permeability in different sampling site in the watershed area.**
