CONDUCT OF RAPID MARINE BIODIVERSITY ASSESSMENT ON THE PROPOSED CAUSEWAY SITE OF INFANTA NICKEL PROJECT UNDER MPSA NO. 220-2005-IVB LOCATED AT BARANGAY MAMBALOT, BROOKE'S

POINT, PALAWAN

CONDUCT OF RAPID MARINE BIODIVERSITY

ASSESSMENT ON THE PROPOSED CAUSEWAY SITE OF INFANTA NICKEL PROJECT UNDER MPSA NO. 220-2005-IVB LOCATED AT BRGY. MAMBALOT, BROOKE'S POINT,

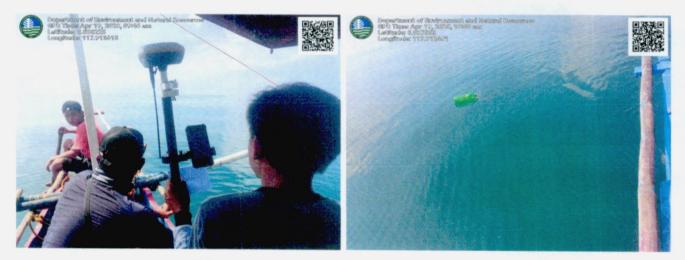
Using the RTK and with the help of Survey Team of the proponent, corners of the proposed site were located to ensure the precision for the conduct of assessment of the proposed site. Four (4) corners including the two (2) located on the sea was marked with buoy which has an estimated depth of 7-8meters.

Relocation of corners and installation of temporary buoy.

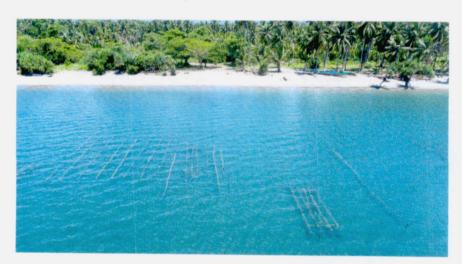
The terrestrial habitat and land use of the proposed area is mainly composed of shore/beach area which has some presence of beach forest species such as Bani and Pandan Dagat. Adjacent to the proposed area are lots planted with coconut plantations and some nipa which are assumed privately owned.

Proposed area for Causeway Project

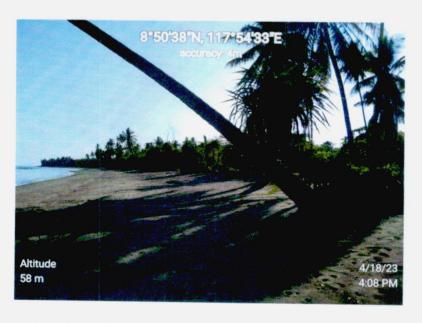
The beach area was relatively flat and extended for several hundred meters along the shoreline. There were also no large rock formations or other hard structures observed in the area and the sand was generally fine-grained and dark in color.

The width of the shoreline from the base of the proposed site has an average of 17 meters during the conduct of assessment (according to tide measurement prediction, the highest tide for April 19, 2023 is at 7:00PM with 0.83m and lowest at 2:00Am with -0.01m).

Beach profile of the proposed area for Causeway project

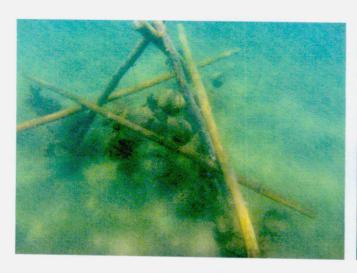
Nonetheless, there were observed lobster traps that are being used by fisher folks or communities nearby in their conduct of aquaculture which can be assumed abandoned due to the state and conditions during the conduct of assessment.

Observed lobster traps at the bottom of the observation point

- 1. Coordination with the Barangay and Municipal LGUs on the list of individuals/families with "baklad"/balsa and lobster trapped within and adjacent (500 meters) from the project area who will be directly affected by the project.

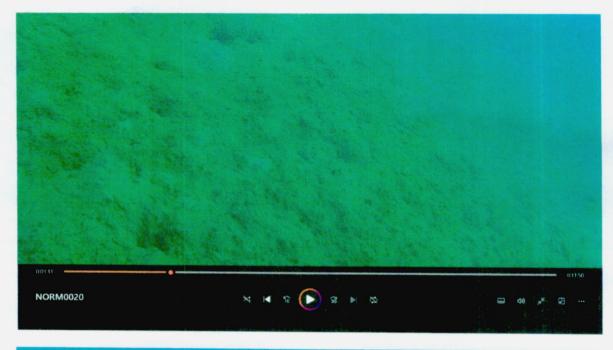
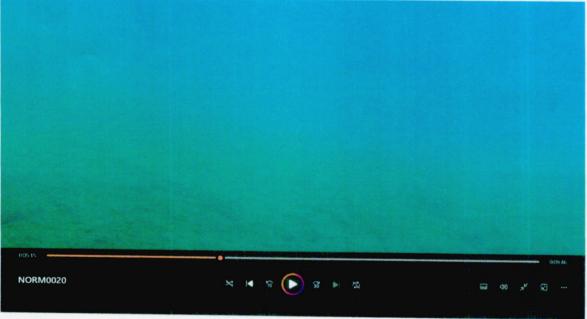
Certified divers of this office conducted diving within the area proposed for Causeway to look for possible group of coral reefs. However, as shown in the photo documentation, the substrate of the proposed area is sand and mud and has no observed traces of coral reefs or even rubbles that can become an indicator that the area has history or accounts of presence of reefs.

Screen captured photos from the video taken by divers

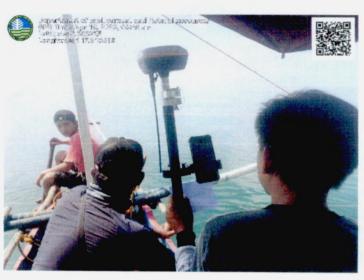
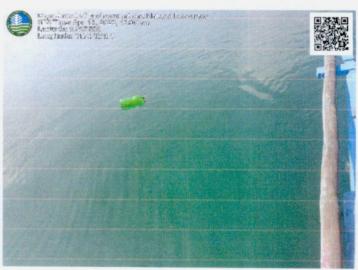
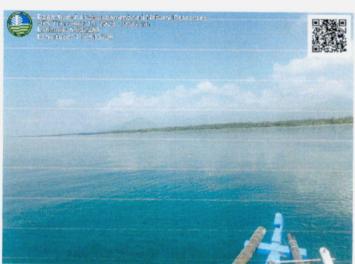
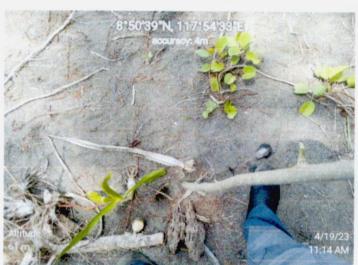
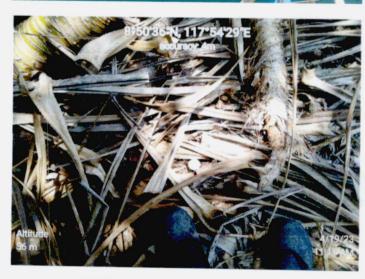
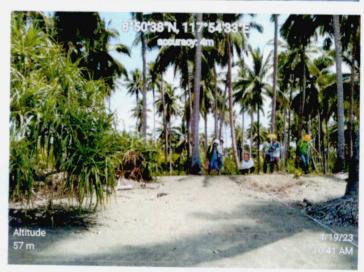
INSTALLATION OF TEMPORARY BOUY AND CORNER IDENTIFICATION

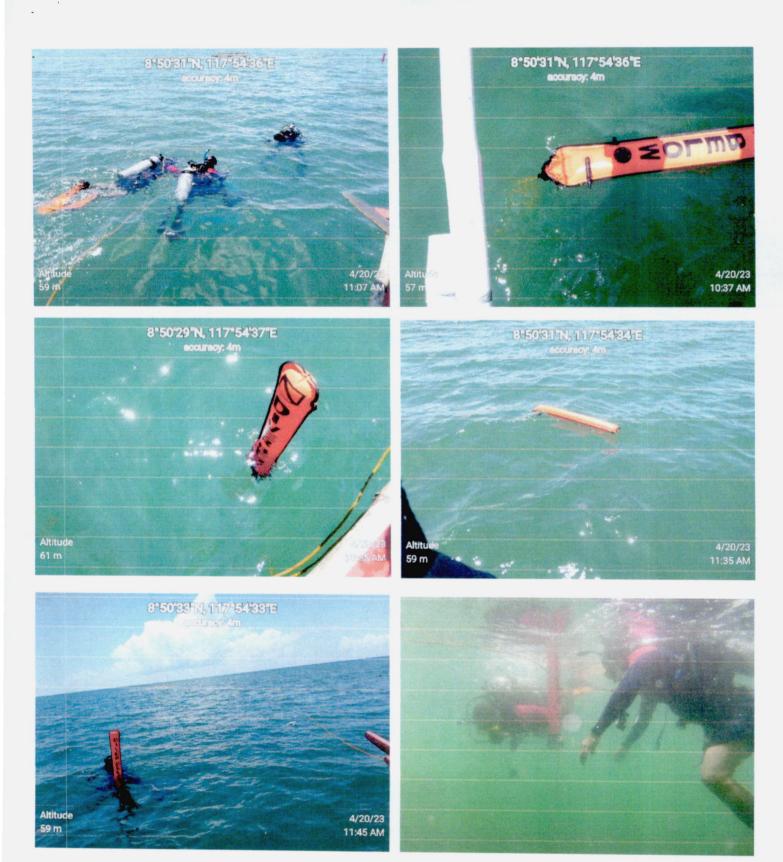
ESTABLISHMENT OF TRANSECT LINES FOR CORAL ASSESSMENT

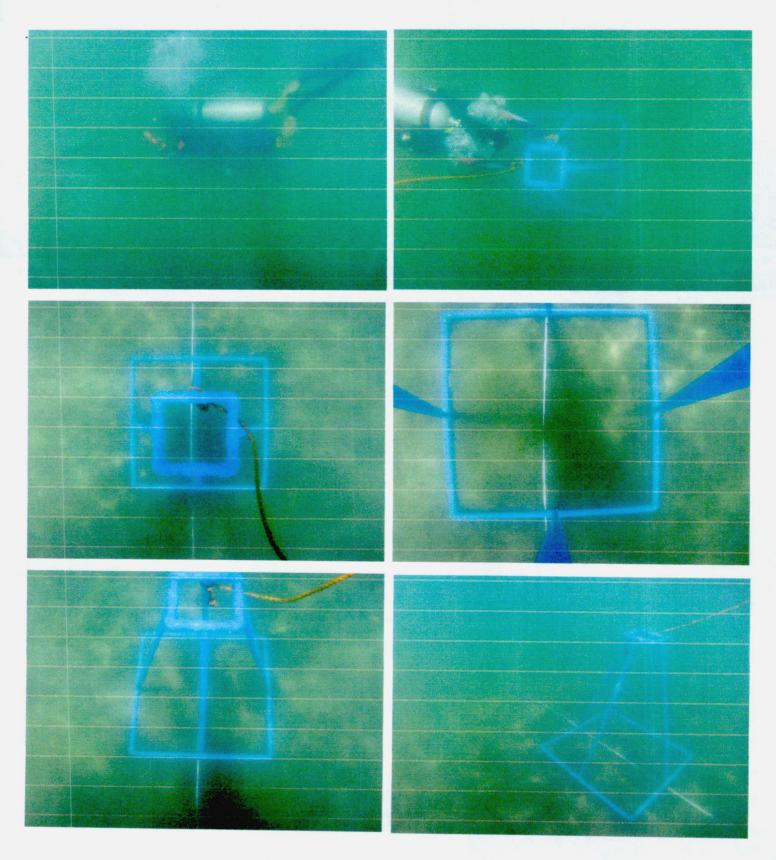
CORAL AND FISH REEF ASSESSMENT

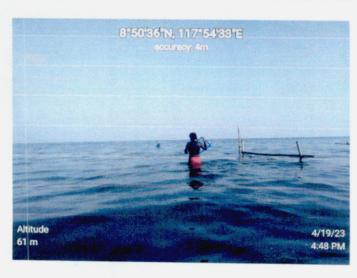
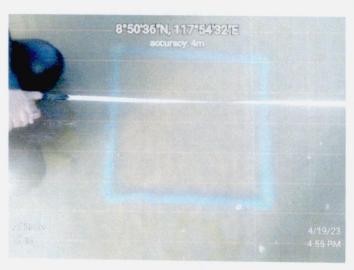
In terms of sea grass assessment, the team laid out six (6) transect line with 25-meters interval and 50-meters length to conduct assessment of the 139 meters width area of the proposed Causeway Project. Observation showed that there are no sea grass present in the proposed area. However, on transect 0+100meters, a species of dead corals were observed. Per analysis and observation of the team, it was only brought by waves since the dead coral is attached in a stone and can be carried by water current.

SEAGRASS ASSESSMENT

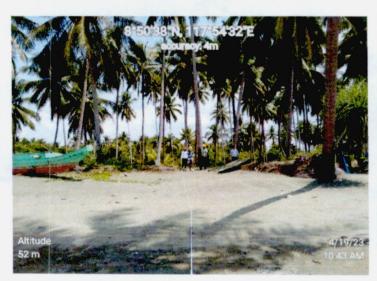
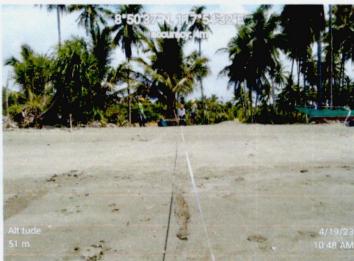
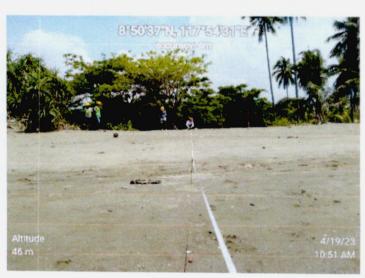
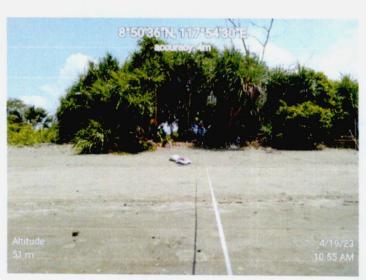
Using the two corners of the proposed area located in the land as baseline to record the width of the beach area, the shoreline were measured at 25 meter interval perpendicular to the baseline going to seaward.

SHORELINE MEASUREMENT

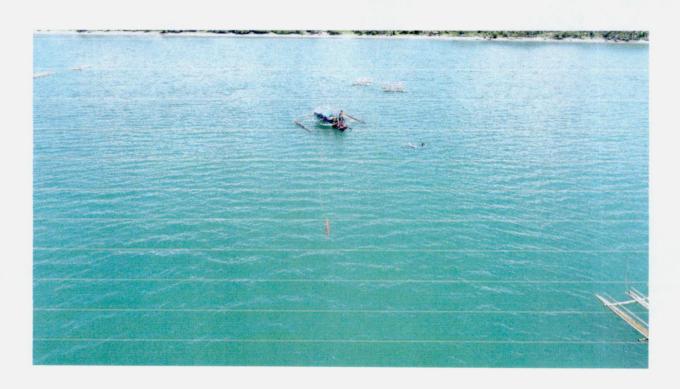
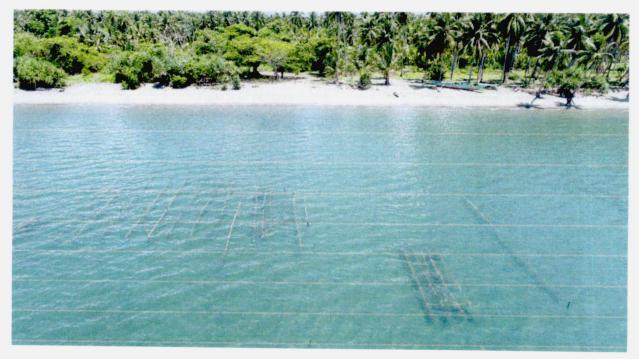
DRONE SHOTS OF THE PROPOSED CAUSEWAY AREA
