SUBJECT : FOLLOW-UP ON ACTIONS TAKEN BY THE MGB, EMB AND
THE DENR AS TO THE JOINT ORDER DATED 06 FEBRUARY 2023

SUBJECT : **TECHNICAL REPORT FOR THE COASTAL RESOURCES
ASSESSMENT (CRA) AT THE CAUSEWAY PROJECT AND
NEARBY REEF SITES IN SIBUYAN ISLAND, ROMBLON**

**Benthic Lifeforms, Marine Macrophytes, and
Associated Fauna Adjacent to the Altai Mining
Causeway in San Fernando, Sibuyan, Romblon**

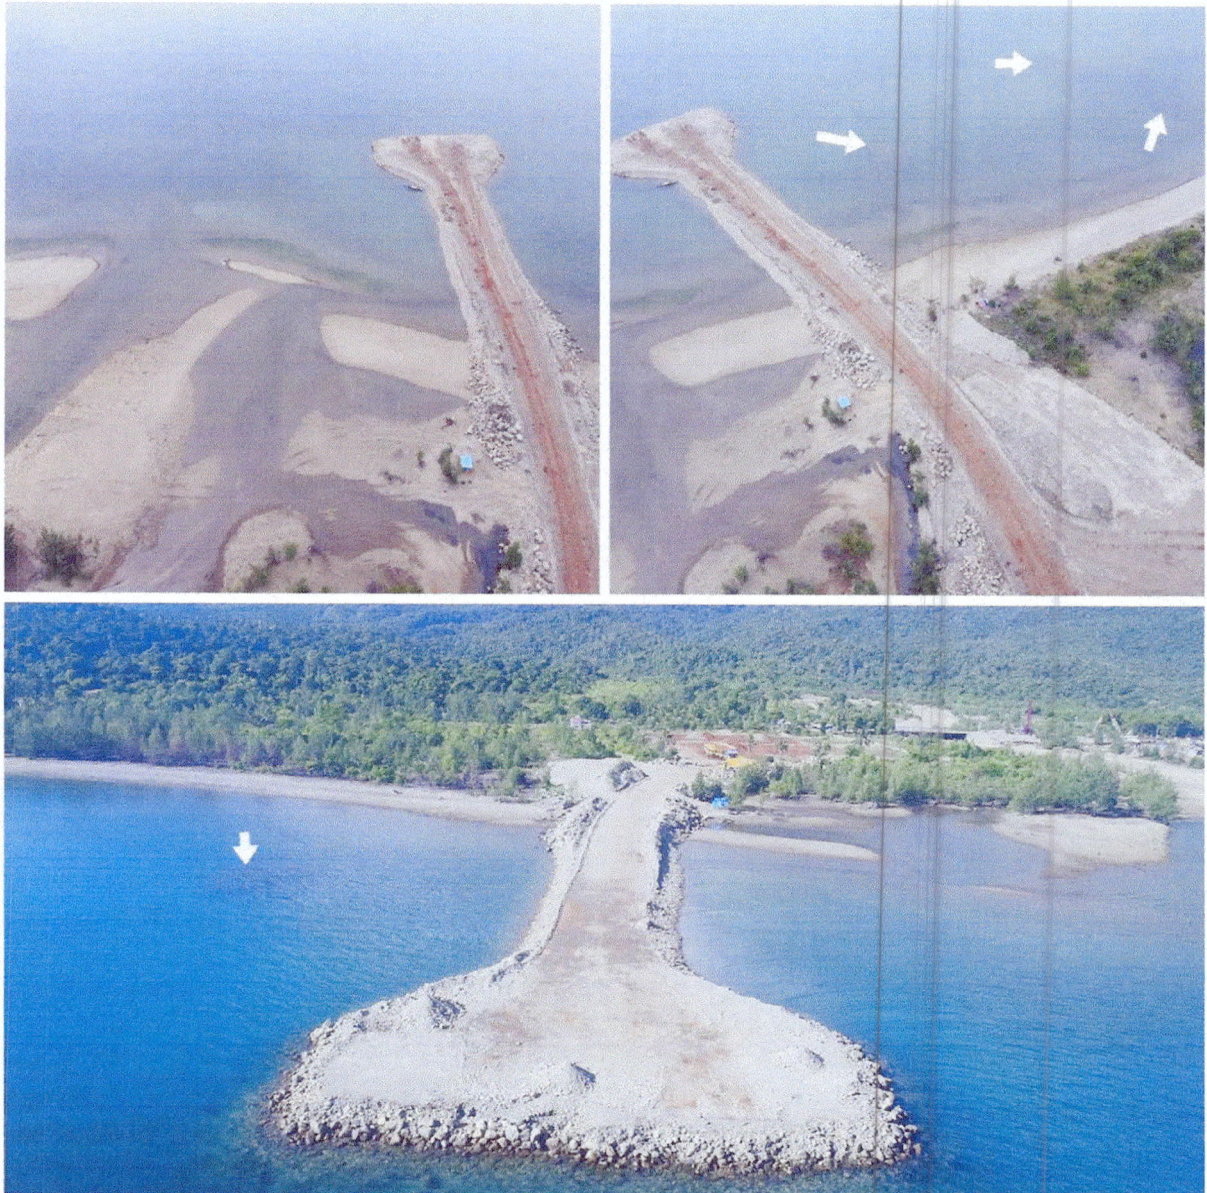
Fig. 2. Location and configuration of the causeway. The closest reef formations or sites are situated on the right side of the causeway (seaward perspective) and marked with white arrows. The left side of the structure is about 70 to 120 m away from the river mouth (Photos by DENR-PENRO Romblon)

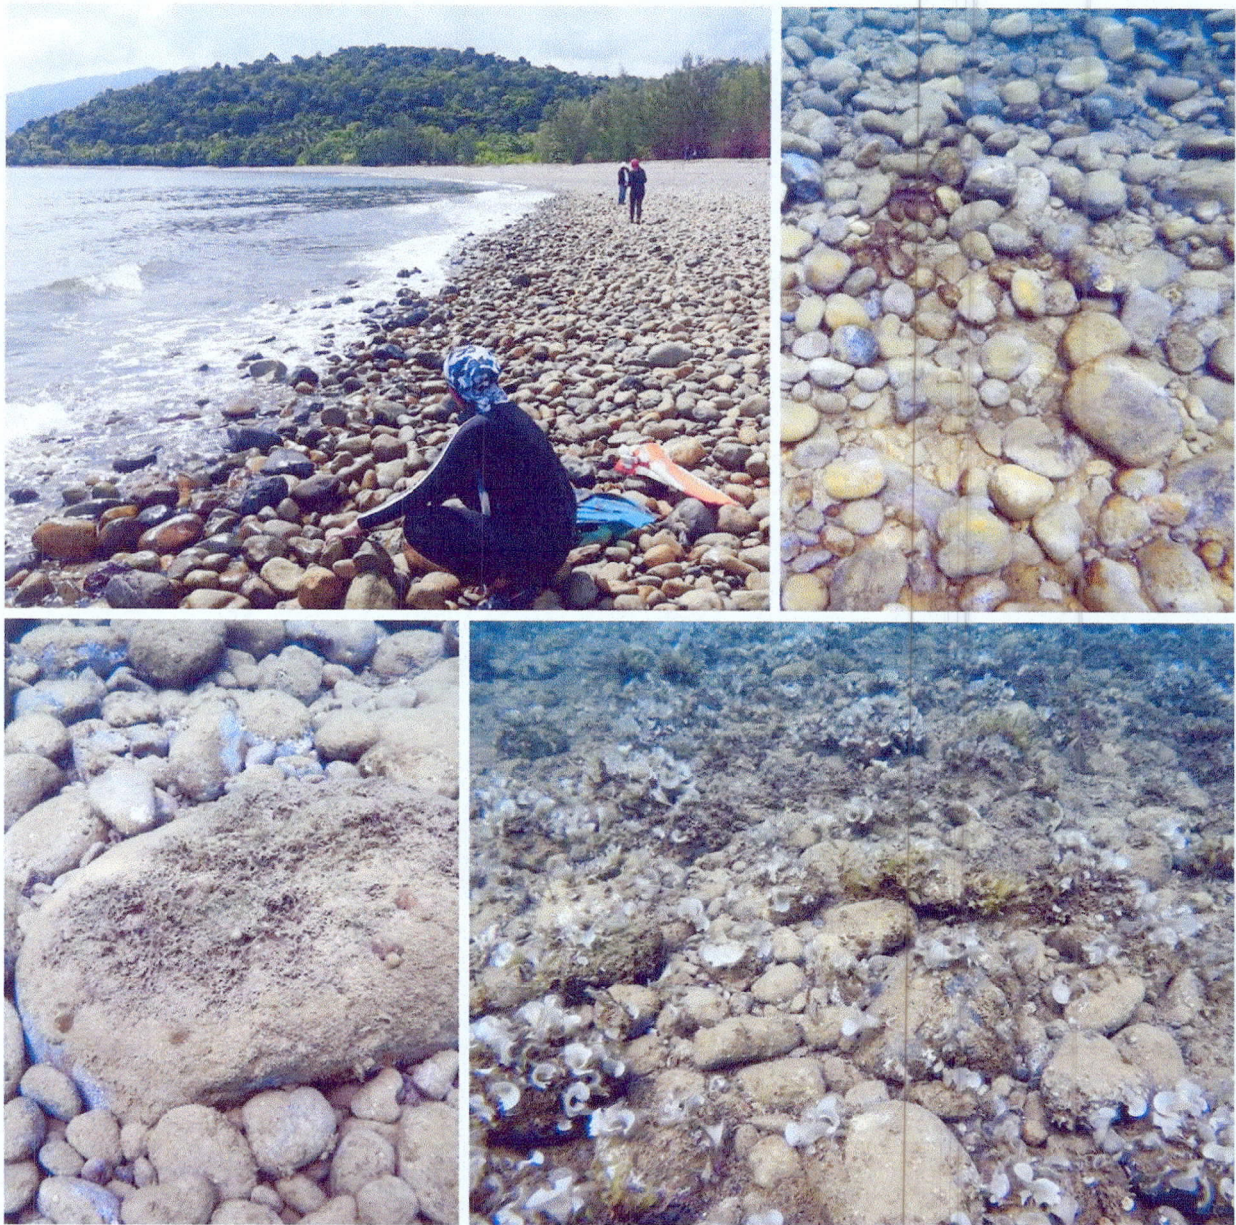
The intertidal area near the causeway was characterized by rocks and pebbles. The same materials were visible in the subtidal area with surfaces covered with thin layers of fine sediments and algal assemblages (**Fig. 4**). Next to the rocky materials were sandy substrate, except for portions with patch reefs. The periphery of the causeway was mostly of rock and boulders (**Fig. 5**). Rock to sandy bottom from the shore to seaward was observed at least 5-10 m from both sides of the causeway. Lateritic particles at the bottom were not noticed at the time of the assessment. Seagrasses, particularly those species that inhabit subtidal areas, were absent at the sandy bottom next to the causeway boulders. Mixed assemblages of fish species occurred on the boulders. A few species of macro-invertebrates were also sighted.

Fig. 4. Features of the tidal flat close to the causeway. The intertidal area is mostly composed of rocks and pebbles (upper photos). These materials in the subtidal area are coated with a layer of fine sediments and algal assemblages (lower photo). (Photos by PENRO Romblon and JIM Padin)

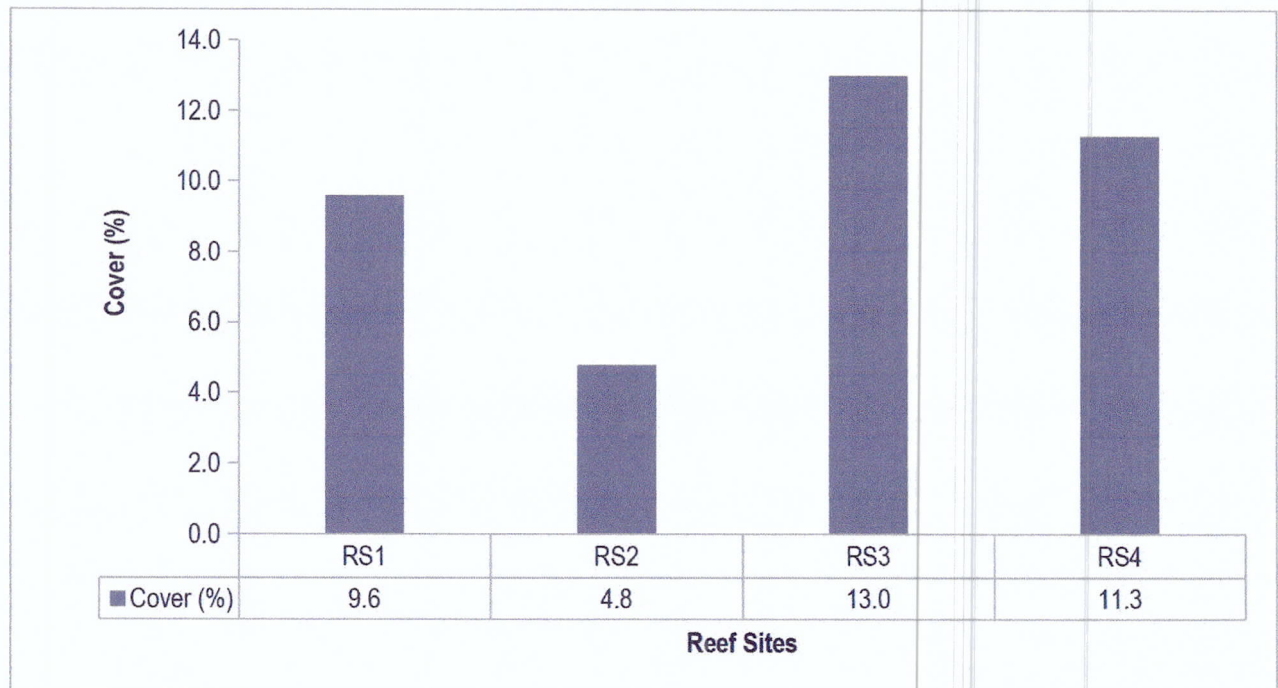
The reef sites were characterized by mostly encrusting, submassive, massive, and branching corals. The highest hard coral cover (HCC) was observed in RS3 (13%), followed by RS4 (11.3%) (**Fig. 8**). The percent cover of benthic lifeforms is presented in **Fig. 9**. The patchy reef in RS3 was dominated by *Sargassum* spp. (70.8%) as well as in RS2 (71.9%). Turf algae were common in RS4 (70.8%) and RS3 (81.5%). Several marine invertebrates were also observed such as species of sponges and crown of thorn starfish (*Acanthaster planci*) (0.4%). Both RS3 (81.5%) and RS1 (52.3%) were dominated by turf algae. The abiotic factor such as the presence of rubbles and rocks was also observed in all sampling sites, which are potential substrate for settlement for coral planulae and recruits to grow. The presence of herbivorous species of invertebrates such as the sea urchins *Salmacis sphaeroides*, *Diadema* sp. and *Echinothrix calamaris* and fish species *Abudefduf lorenzi*, *Abudefduf vaigiensis*, *Chaetodon kleinii*, *Dascyllus melanurus*, *Plotosus lineatus*, *Pomacentrus bankanensis*, *Siganus guttatus* and *Zebrasoma scopas* can be attributed to the dominance of algae.

Fig. 8. Hard coral cover (HCC) at the four reef sites adjacent to the causeway.
