ACCOMPLISHMENT REPORT ON WATER QUALITY MONITORING WITHIN PROCLAIMED NIPAS PROTECTED AREA UNDER MARINE PROTECTED AREA STRENGTHENING AND NETWORKING OF EL NIDO MANAGED RESOURCE PROTECTED AREA (ENMRPA) FOR

THE MONTH OF APRIL CY 2023

REPORT ON WATER QUALITY MONITORING WITHIN

(ENTMRPA) FOR MONTH OF MAY CY 2023

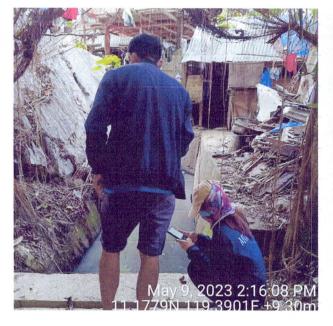
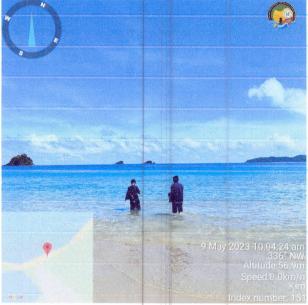
PHOTO DOCUMENTATION

This is to certify that the above photos were true and correct and taken during the Water Qulaity Monitoring activity of EMB-PEMU and ENMRPA for the month of May 2023.
