SUBJECT : REQUEST FOR TECHNICAL ASSISTANCE FOR THE
INSPECTION OF MOGPOG RIVER, MUNICIPALITY OF
MOGPOG, MARINDUQUE

SUBJECT : **INITIAL INVESTIGATION REPORT REGARDING**
SILTATION/SOIL EROSION AT MOGPOG RIVER
MARINDUQUE

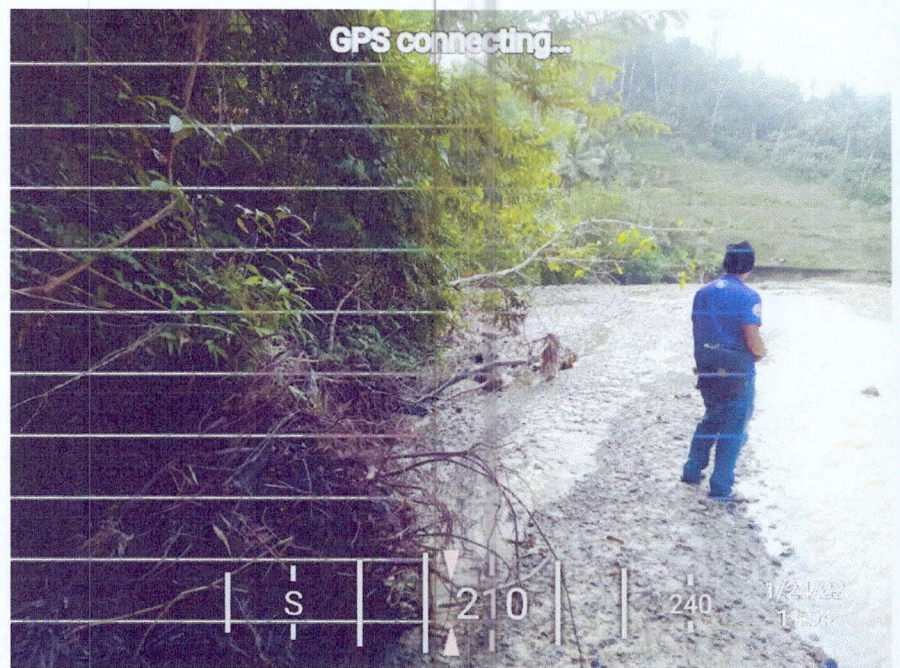
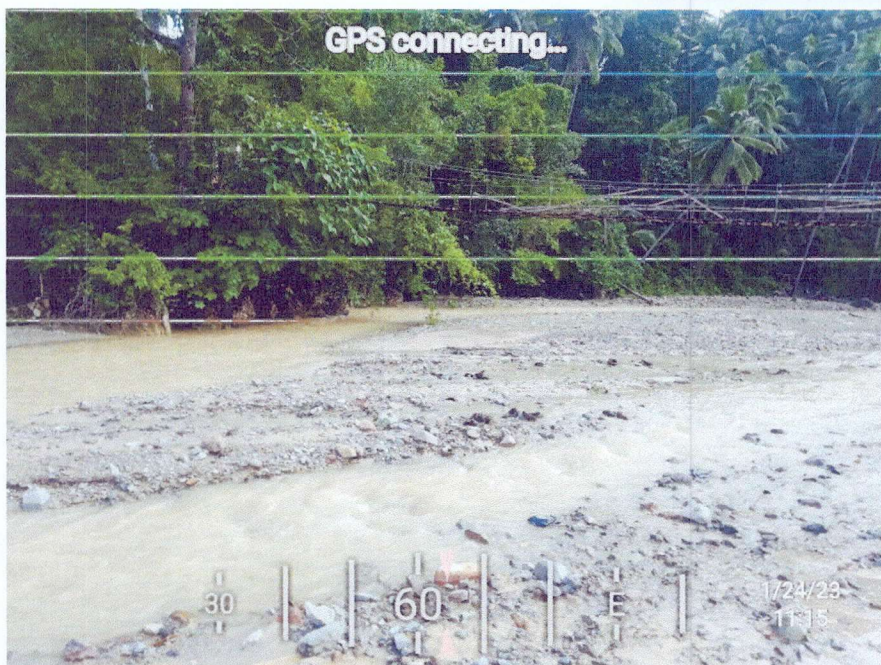
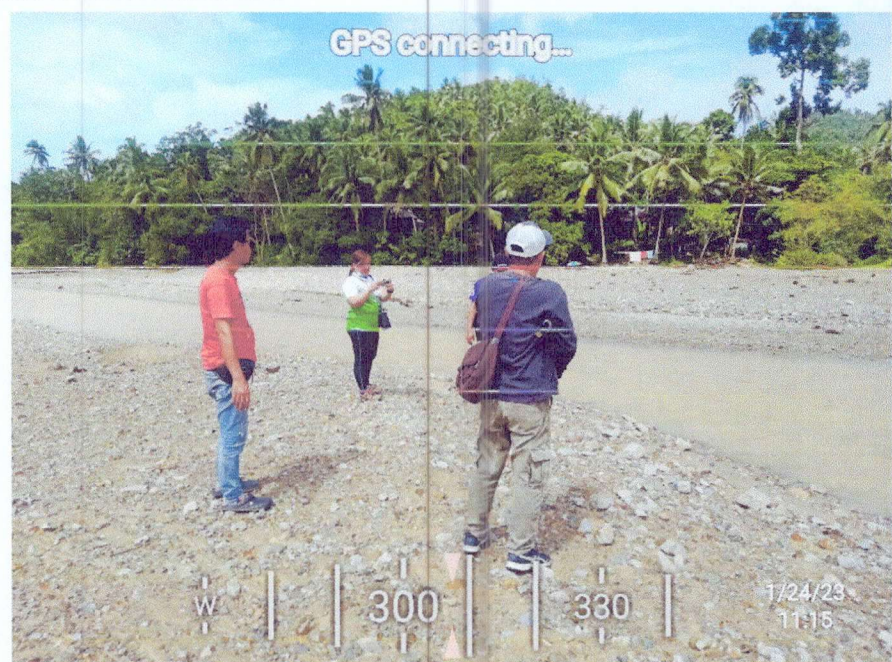
1. Upon closer observation, the water appears to have turned brown, purportedly as a result of Typhoon "Paeng" in October of 2022. However, when the barangay chairman Logatoc was interviewed, the river's appearance was typically stagnant, its color dark to semi-brown and the majority of the particles were gravel and sand.
2. Existence of some houses and establishment along Mogpog River was observed;
3. Presence of waste materials mostly plastics and bottles was seen;
4. Most of the vegetation along the River are mostly *ficus* species and coconut.
5. During the interview with barangay chairwomen Logatoc, their area often experience flooding and landslide.

Geotagged photos during the conduct of ocular inspection of Mogpog per request of Mogpog Municipal Mayor, Honorable Augusto Leo M. Livelo at Barangay Bocboc, Mogpog, Marinduque

In view of this, the team recommends technical assistance from Mines and Geo Science Bureau to conduct an in-depth investigation into the said matter.

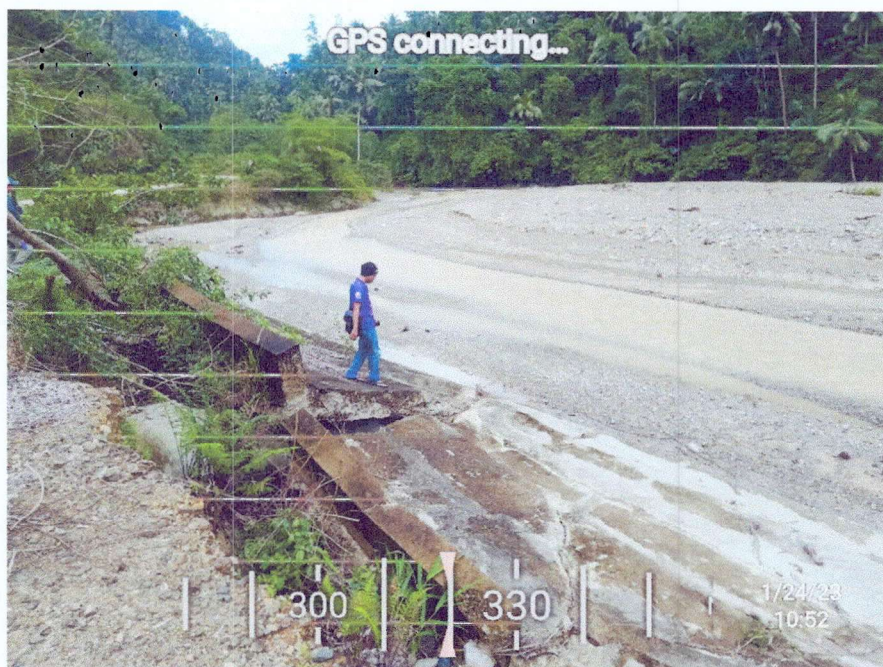
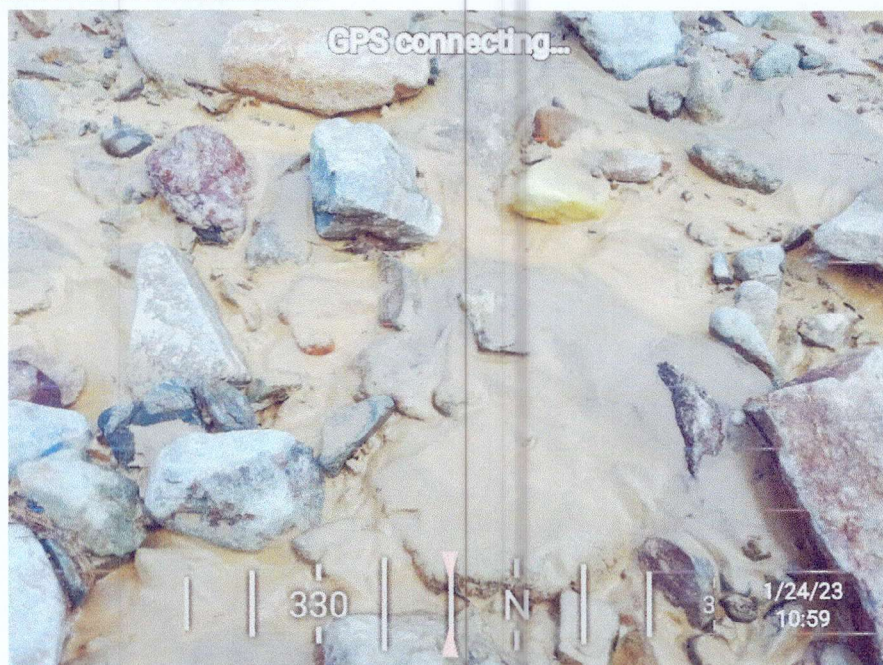
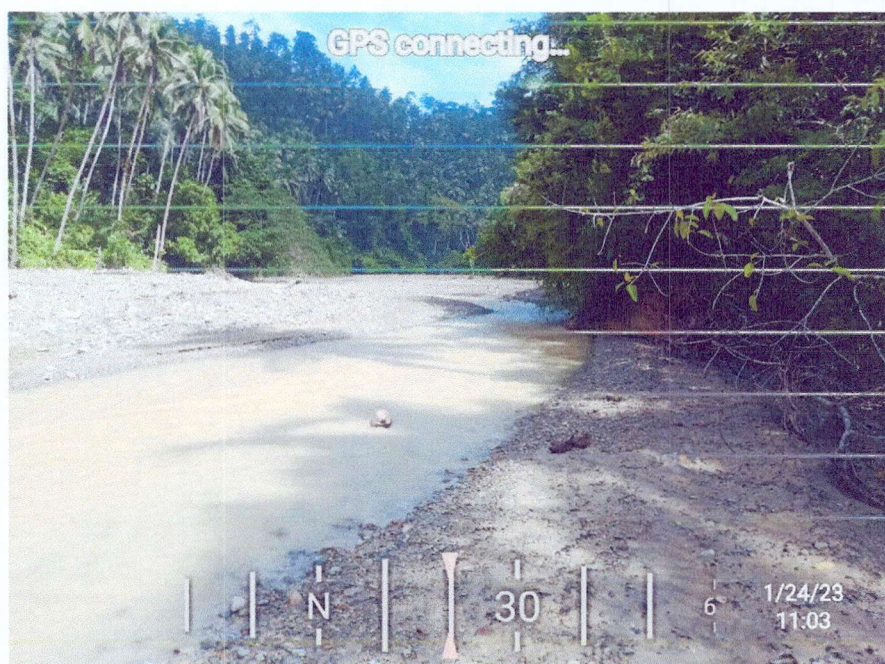
Geotagged photos during the conduct of ocular inspection of Mogpog per request of Mogpog Municipal Mayor, Honorable Augusto Leo M. Livelo at Barangay Bocboc, Mogpog, Marinduque

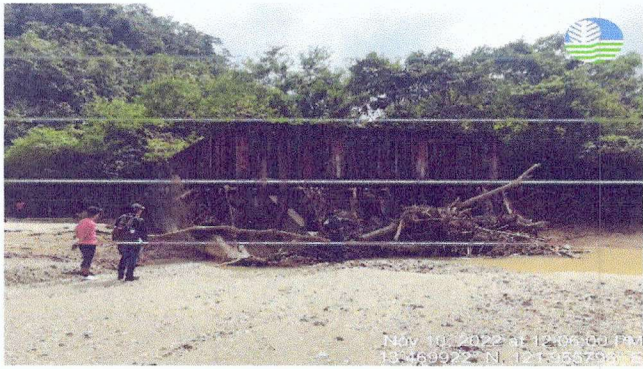
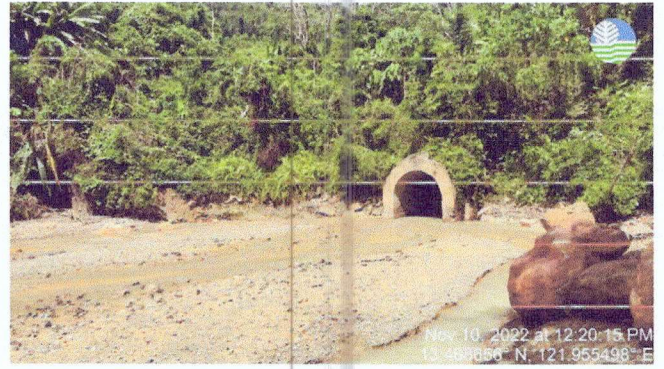
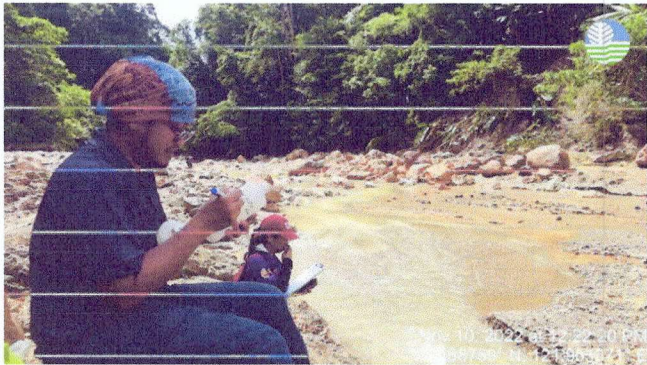
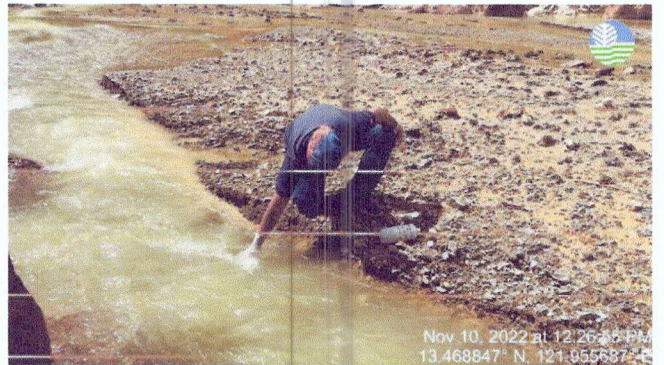
On November 10, 2022, an inspection/monitoring of the Environmental Management Bureau (EMB)-MIMAROPA Region headed by Mr. Marc Kinit M. De Leon conducted water sampling activity at Maguila-guila Siltation dam, with geo-coordinates "13.468697 N, 121.965471 E" (contaminated by mine waste/tailing) located at Brgy. Bocboc, Mogpog Marinduque. On-site water sampling was conducted at 12:22 pm. (result of laboratory analysis is still pending).

Photo documentation of water sampling activity conducted on November 10, 2022.
