SUBJECT : INVESTIGATION REPORT ON RIVER DREDGING SAND AND GRAVEL EXTRACTION IN CORON, PALAWAN

22 March 2022

SUBJECT : INVESTIGATION REPORT ON RIVER DREDGING SAND AND
GRAVEL EXTRACTION IN CORON, PALAWAN

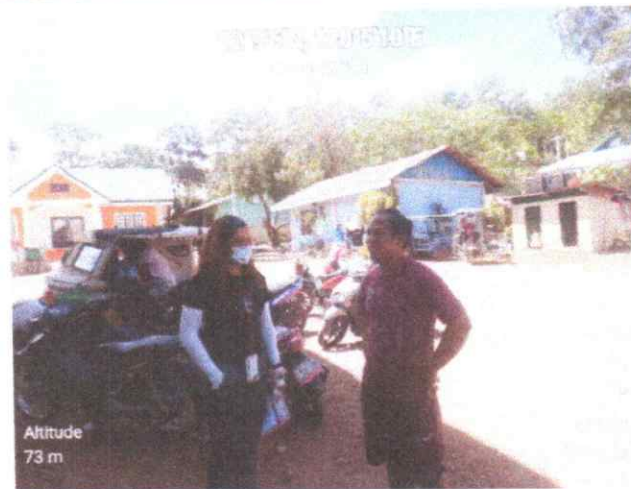
Photo Documentation 03
PACECO, Brgy. Decalachao

Former river quarry in PACECO, Brgy. Decalachao. The flow of Papualan River was blocked by the probably a former stockpile. Third photo was during the courtesy call in the barangay.

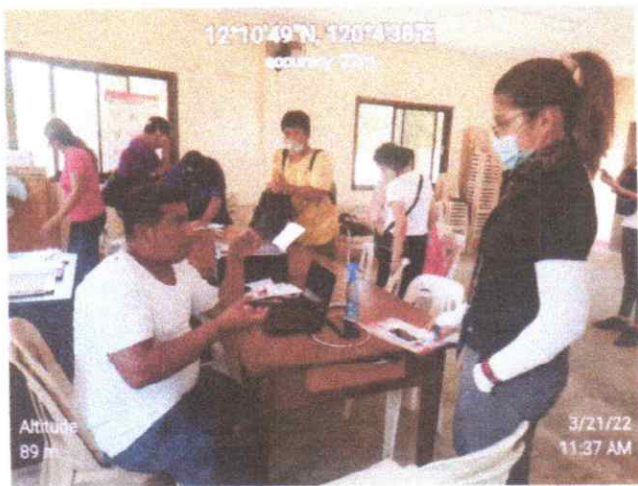
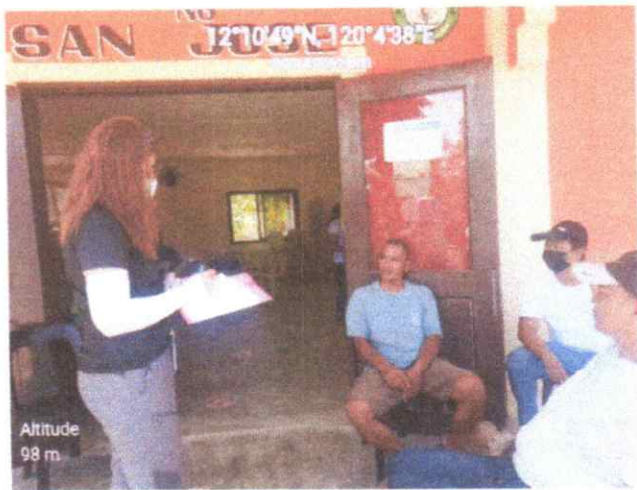
Sitio Babuy and Kawayan, Brgy. San Jose

Courtesy call and initial interview with Brgy Captain Villareal and other barangay officials regarding the quarry operation in the area.

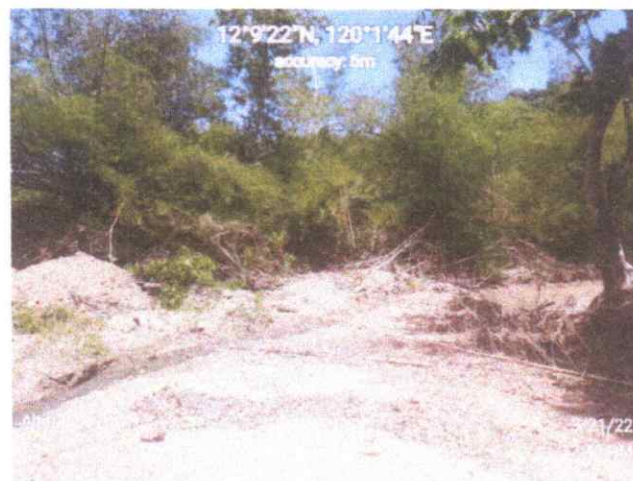
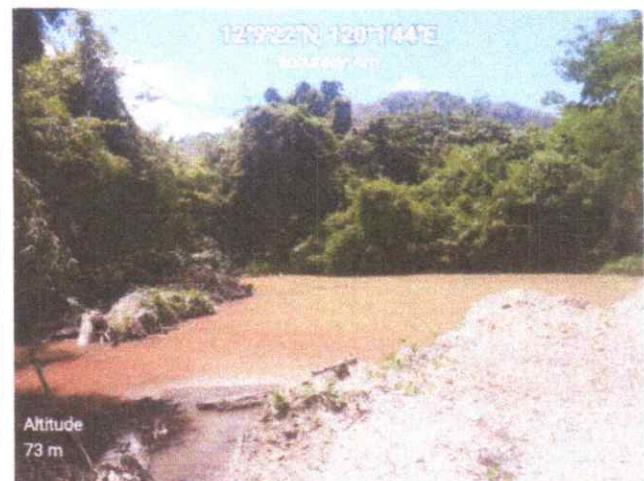
4. During the investigation, there was no ongoing excavation of the area. A parked backhoe, however, was observed. Stockpiles of sand excavated riverbanks and blocked river are among those we saw (*see Photo Documentation 04*). No ECC was also posted near the area.

5. In this area, the river is heavily disrupted. It was even cut as the excavated materials were dumped in the river. This result in some part of the river being stagnant. Trees along the riverbank were also damaged (*see Photo Documentation 04*).

SAG excavation in Brgy. San Jose. The river flow is highly disrupted by the haphazard extraction and dumping/stockpiling of SAG. Trees and other vegetation were also damaged by the operation.
