**MEMORANDUM**

**SUBJECT :** **FIELD INVESTIGATION REPORT ON THE INCIDENT OF SLURRY LEAK AT THE HIGH PRESSURE ACID LEACH PLANT OF CORAL BAY NICKEL CORPORATION DUE TO NORMAL WEAR (PRESENCE OF SMALL HOLE) OF THE DISCHARGE PIPE FROM THE AUTOCLAVE**

**SUBJECT** : **FIELD INVESTIGATION REPORT ON THE INCIDENT OF SLURRY LEAK AT THE HIGH PRESSURE ACID LEACH PLANT OF CORAL BAY NICKEL CORPORATION DUE TO NORMAL WEAR (PRESENCE OF SMALL HOLE) OF THE DISCHARGE PIPE FROM THE AUTOCLAVE**

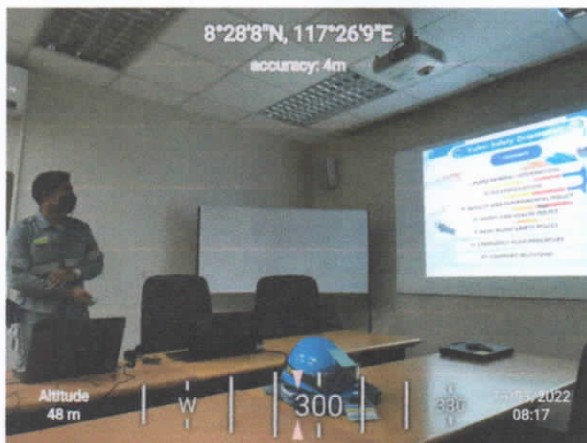
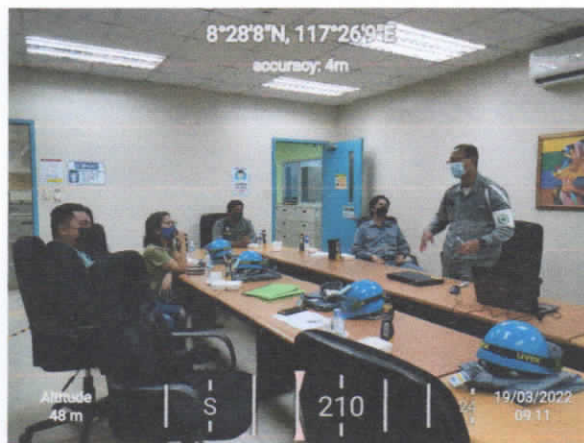
### Safety Orientation and Discussion on the Slurry Leak Incident

The inspection team was briefed on the safety protocols of the company prior to the site inspection and was provided detailed information on what had transpired during the incident.

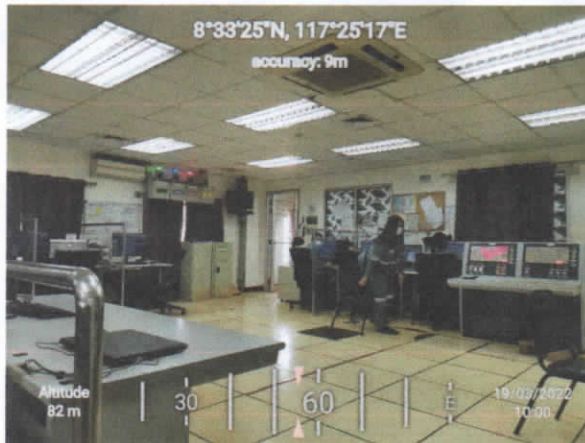
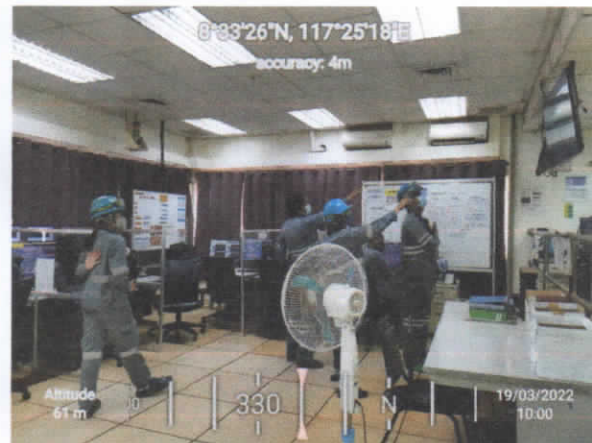
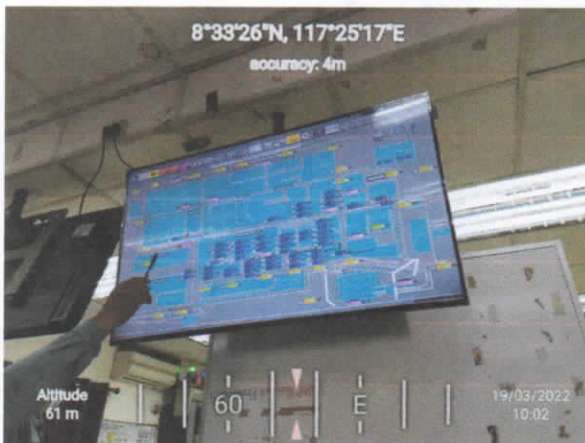
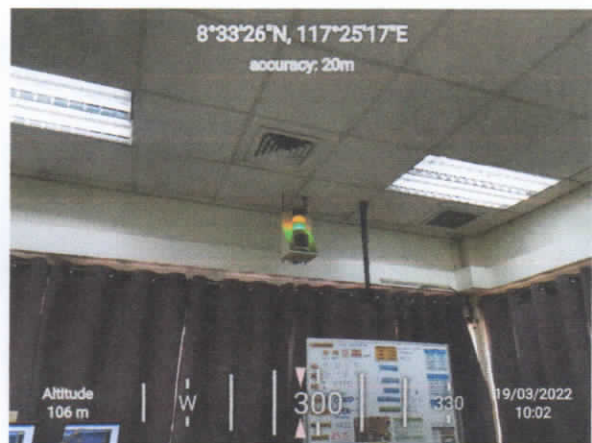
## Distributive Control System of CBNC

DCS personnel continuously monitor the pH level, hydrogen sulfide gas level (chemical formula:  $\text{H}_2\text{S}$ ), wind direction, etc.
