SUBJECT : SUBMISSION OF REPORT ON THE CONDUCT OF
MONITORING OF MONUMENTS ON DEMARCATED
BOUNDARIES OF MT. GUITING – GUITING NATURAL PARK,
SIBUYAN ISLAND, ROMBLON

SUBJECT : **REPORT ON THE CONDUCT OF MONITORING OF
MONUMENTS ON DEMARCATED BOUNDARIES OF MT.
GUITING – GUITING NATURAL PARK, SIBUYAN ISLAND**

**PHOTODOCUMENTATION DURING THE CONDUCT OF MONITORING OF
MONUMENTS ON DEMARCATED BOUNDARIES OF MT. GUITING – GUITING
NATURAL PARK, SIBUYAN ISLAND**

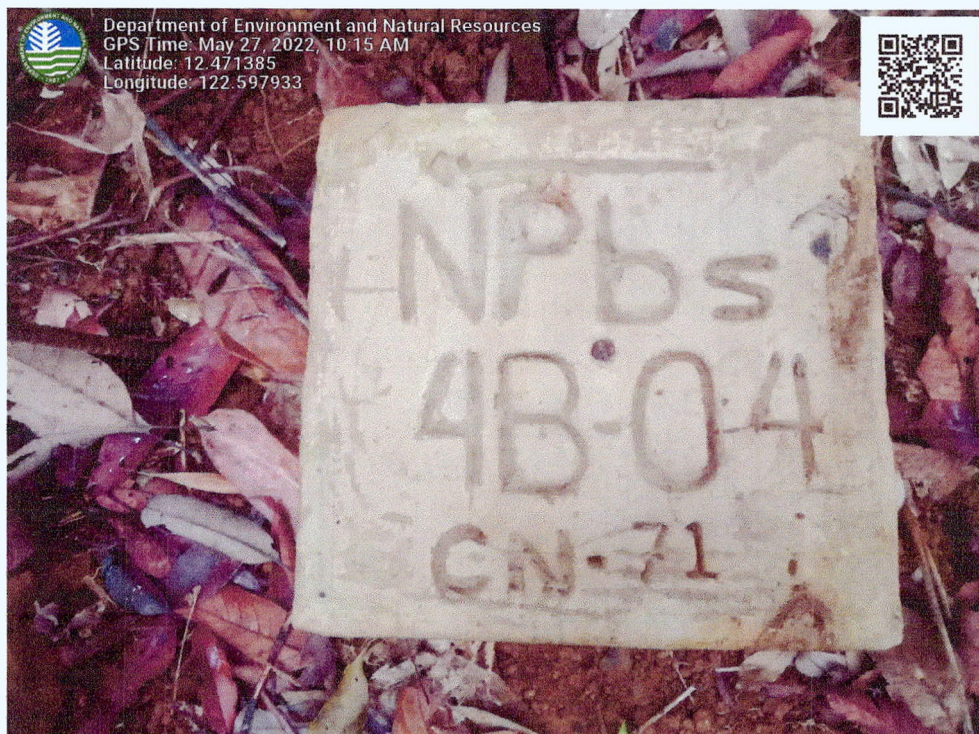
Out of the 132 monuments installed, only one (1) was destroyed. It is recommended to re-construct the said monument located at Brgy. Cantagda, Cajidiocan, Romblon. During the inspection, the DENR patrollers had observed the destruction of some signages in areas like Brgys. Cantagda, and Lumbang Weste, Cajidiocan, and Taclobo, Panangcalan, San Fernando. After an investigation/discussion, some of the Indigenous Peoples sees the signages as an intimidation/threat of their Ancestral Domain. Thus, the DENR personnel conducted an extended IEC with the IP community, the IPs raised the issue that hopefully, the signages would also contain their logo, and include in the sign that aside from entering the Protected Area, they are entering an Ancestral Domain as well. Thus, this Office recommends to include the maintenance of signages and its fund allotment for the future target activities of this Office.

The destroyed Monument Corner no. 70 at Brgy. Cantagda, Cajidiocan, Romblon.
