**MEMORANDUM**

**SUBJECT** : **UPDATES ON THE HALF-SUBMERGED VIETNAMESE VESSEL  
(VIET HAI STAR) IN BALABAC, PALAWAN**

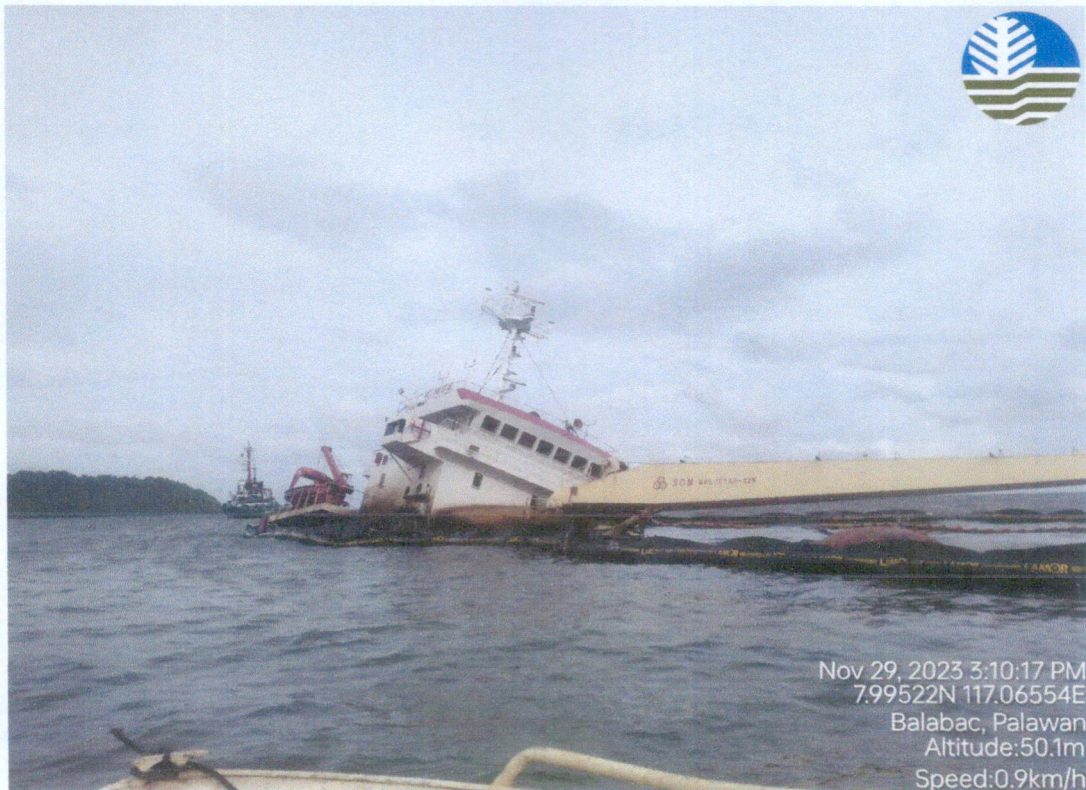
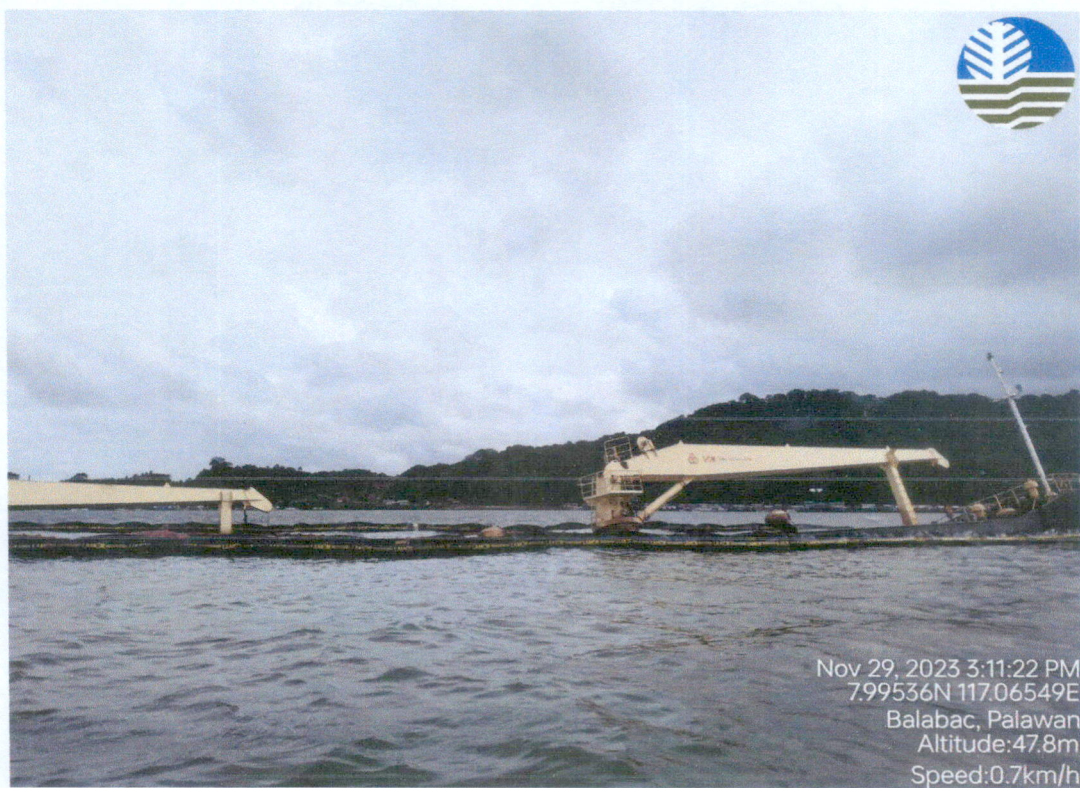
Further, underwater inspection was conducted by the PCG, it was noticed that the source of oil spill is from the exhaust vent (gooseneck vent) which is suspected from a sludge tank located on the starboard side (right side) midship of the subject vessel flowing in the direction going to the shoreline, 400 yards NW off Balabac, Palawan. Based on the underwater inspection of PCG, the FES Challenger Marine and Builders personnel conducted diving operations to survey and patch the areas of oil leak. The dive team patched/closed four (4) blowers, six (6) air vents, one (1) chimney door, four (4) doors and four (4) windows.

**Actual situation and location of Viet Hai Star as of November 29, 2023**

Moreover, additional improvised oil spill boom was provided by MRDDMO Balabac and additional oil spill boom from Coast Guard District Palawan were laid out around the vessel. Thereafter, the PCG continued the application of dispersants, manual scooping of oil spill and absorbents on the oil trapped within the boom.

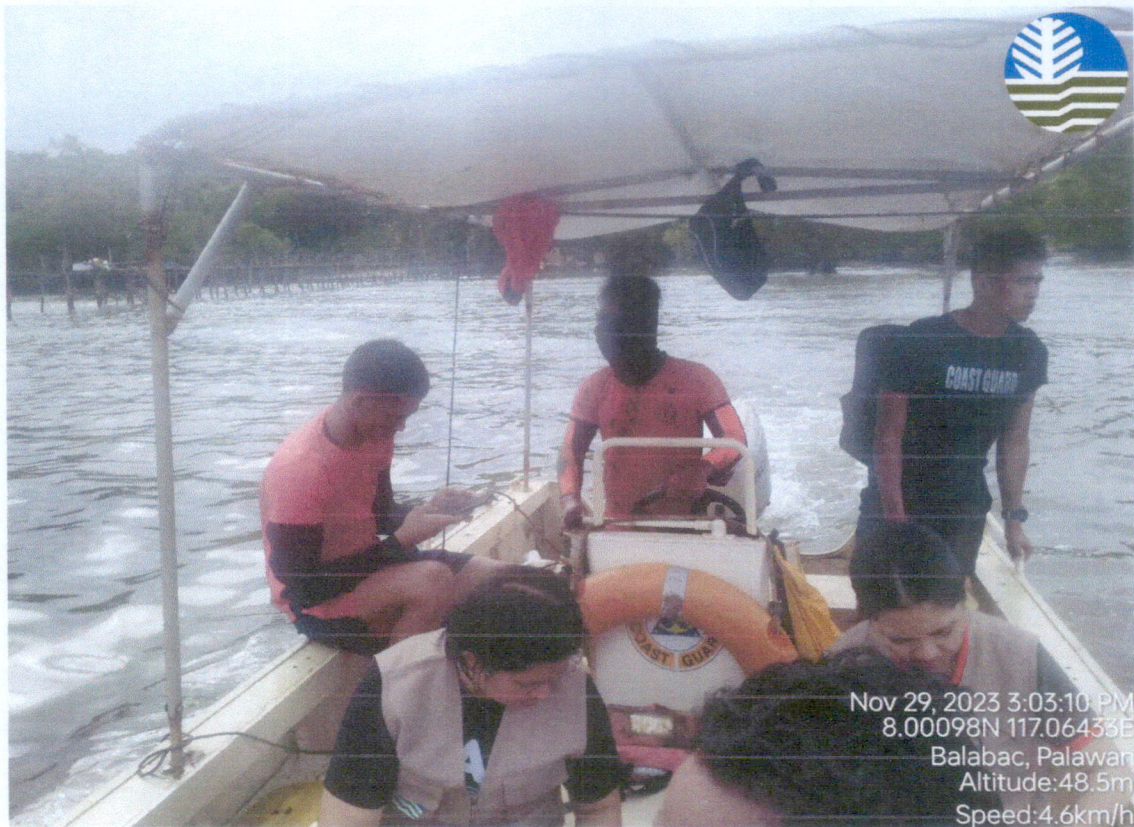
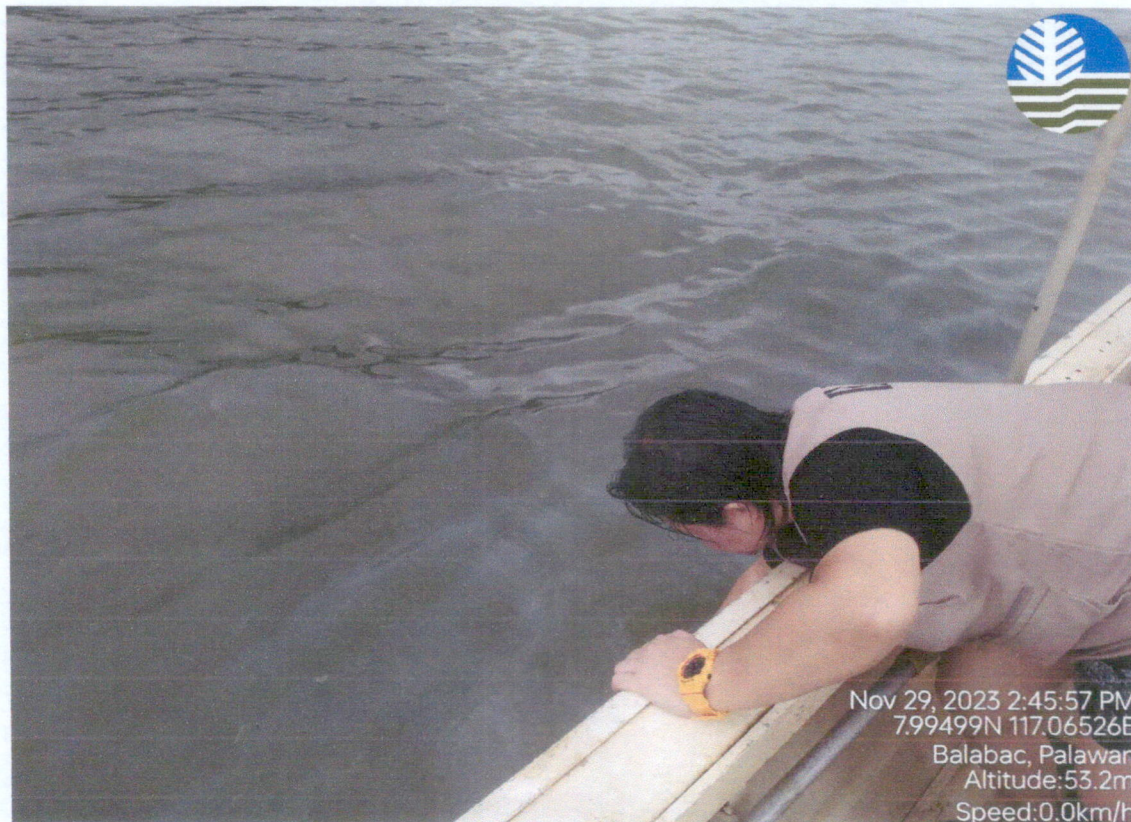
Currently, the DENR-PEMU coordinated with LGU Balabac (MENRO, MDRRMO) and PCG regarding the incident and conducted water sampling activity within the vicinity waters of the affected Barangays (please see attached photos).

**Water sampling activity conducted by DENR-PEMU**

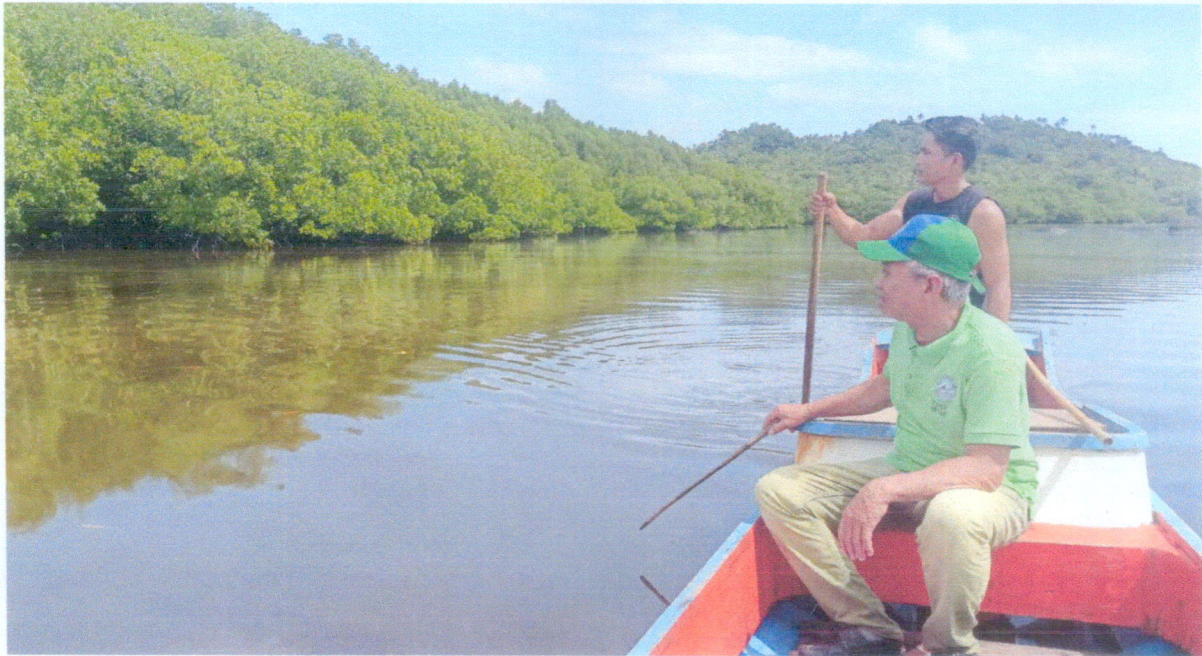
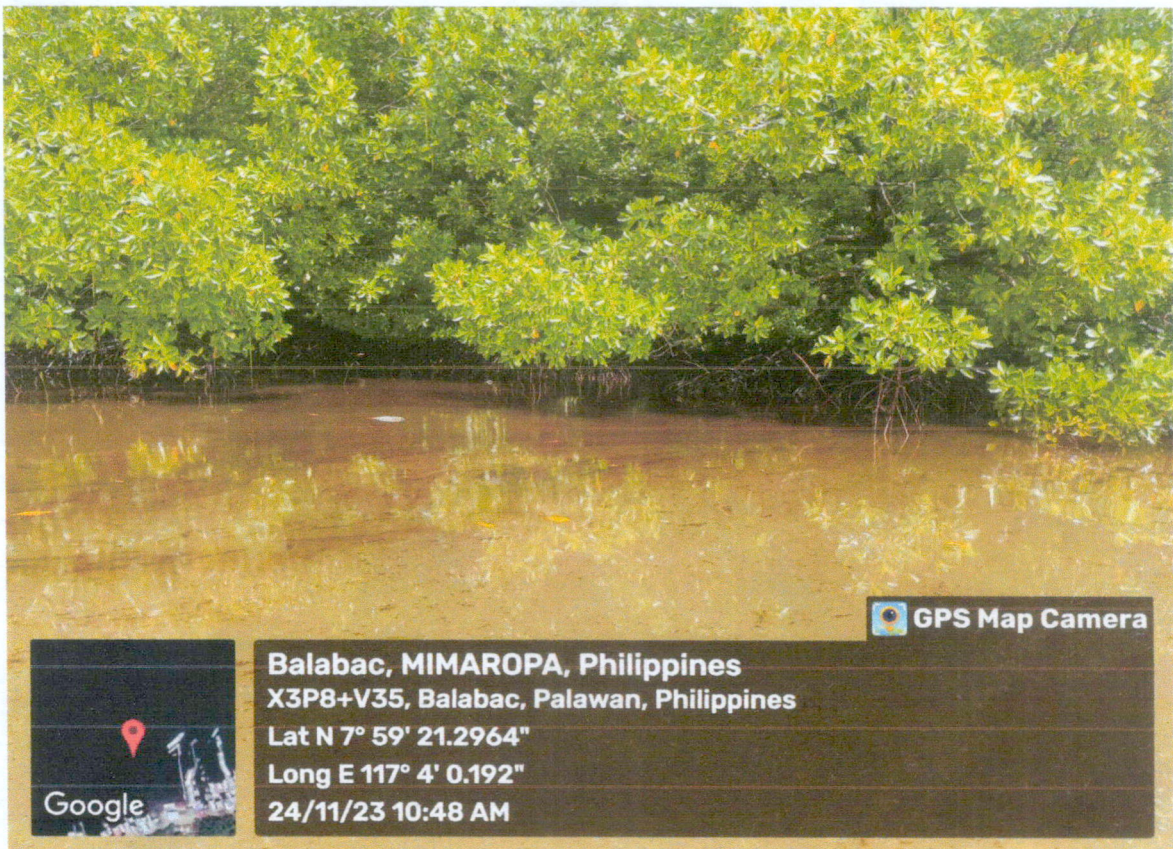
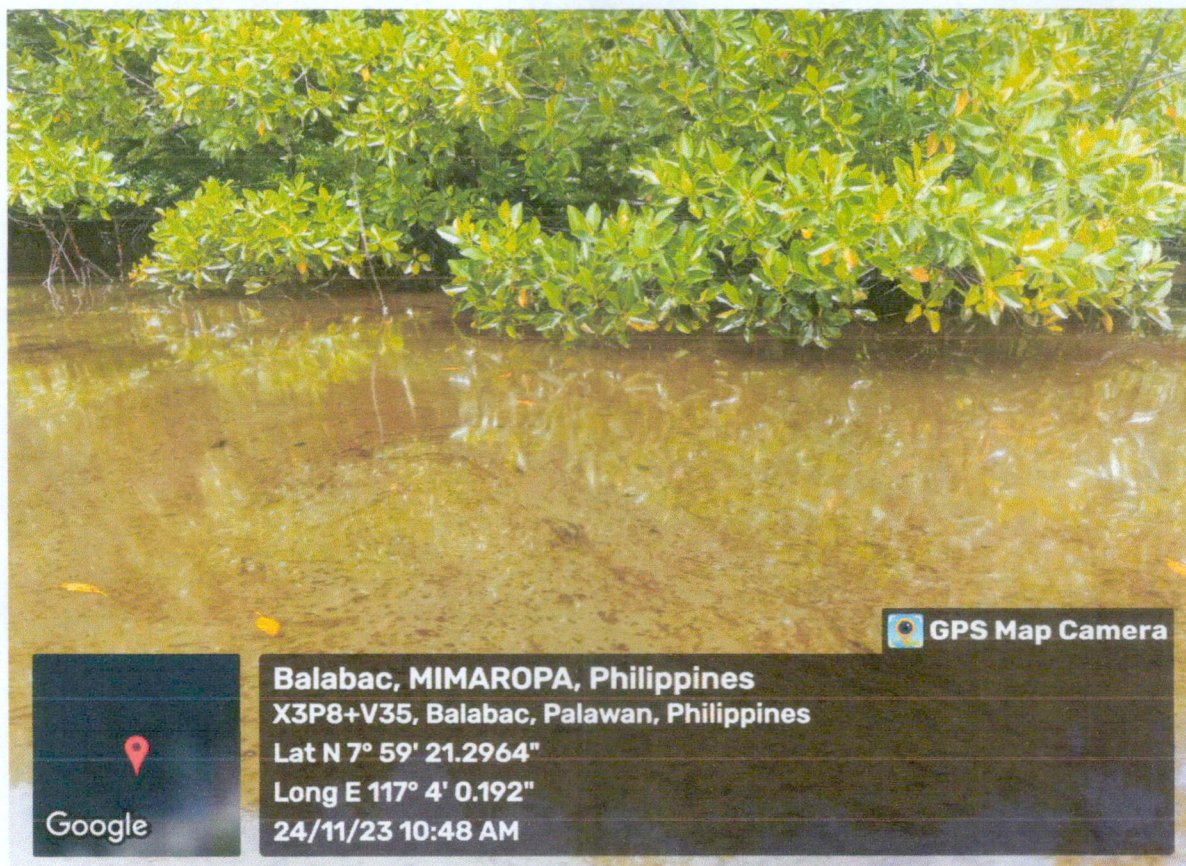
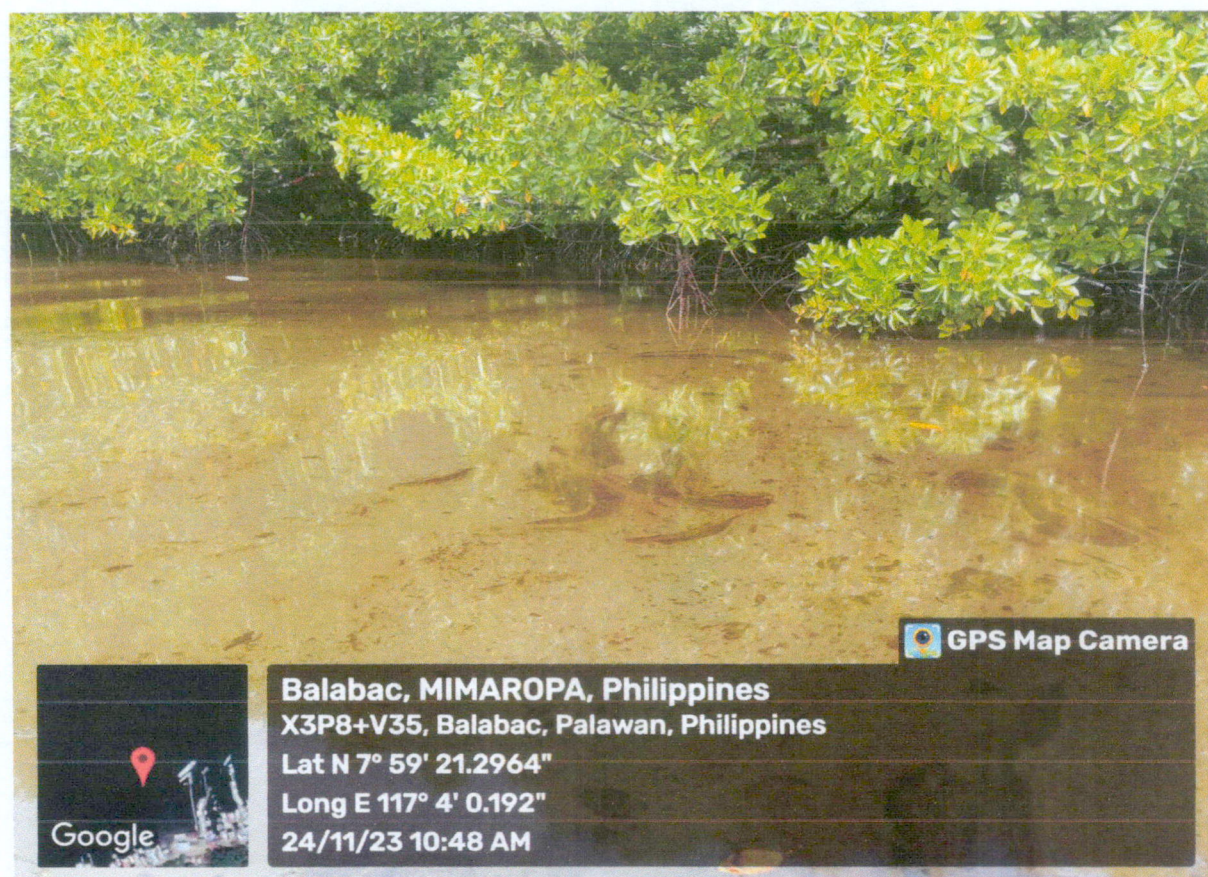
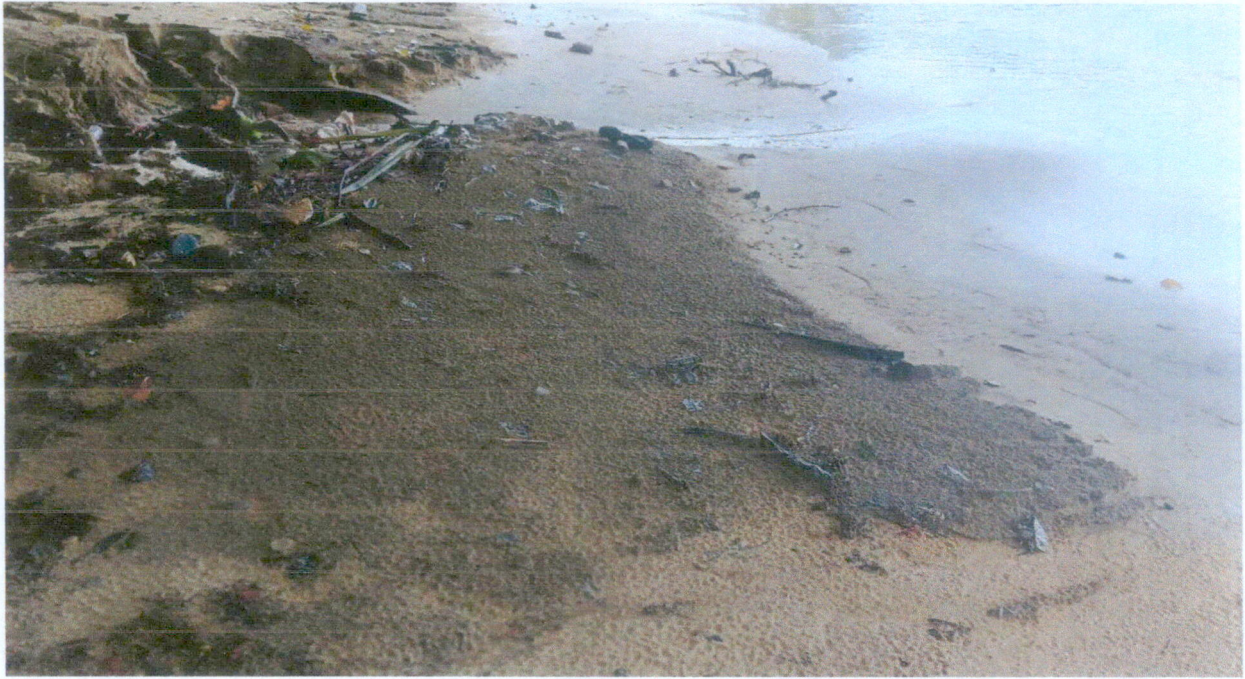
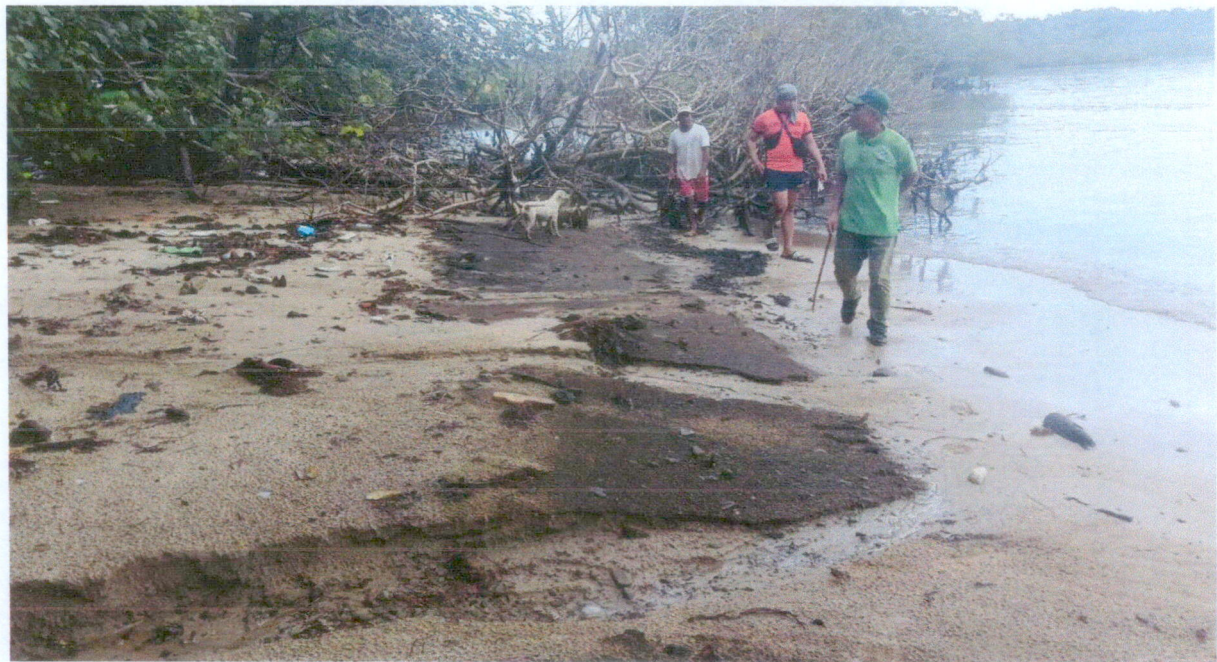
According to the report of the Municipal IMT, as of November 28, 2023, there are four (4) barangays which were affected by the oil spill. These are Barangays Poblacion 3, 4, 5, and 6 wherein there are evidences of contamination of the shoreline/baywalk areas/beach areas and contamination of mangrove areas (please see attached photos).

**Actual photos showing the affected areas of oil spill**

Simultaneous and continuous coastal/shoreline clean-ups are being conducted by the PCG, PDRRMO, PNP-MARIG, crews of Viet Hai Star and other Barangay Volunteers led by MENRO which resulted to a collection of total of 10.5 drums (20,500 liters) of oily water mixture and 1,045 contaminated debris (mixture of contaminated sand, wood, and absorbent pads).
