TASK FORCE MT. PRINCESS EMPRESS OIL SPILL INCIDENT

SITUATIONAL REPORT NO. 47

17 April 2023

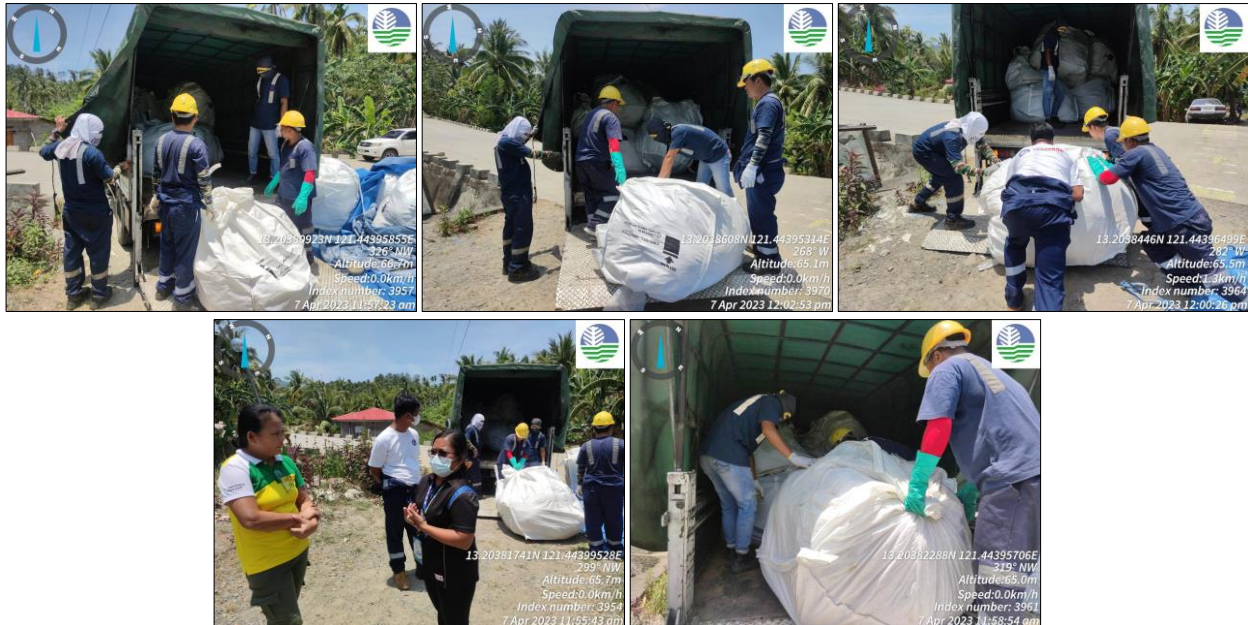
Hauling in Brgy. Tagumpay, Pola, Oriental Mindoro

On 07 April 2023, EMB MIMAROPA Region facilitated and monitored the hauling of oil contaminated materials at the collection point located at Brgy. Tagumpay and in various barangays of Pola, Oriental Mindoro. Representatives from Philippine Coast Guard, LGU Pola, ITOPF, and Harbor Star were present during the activity.

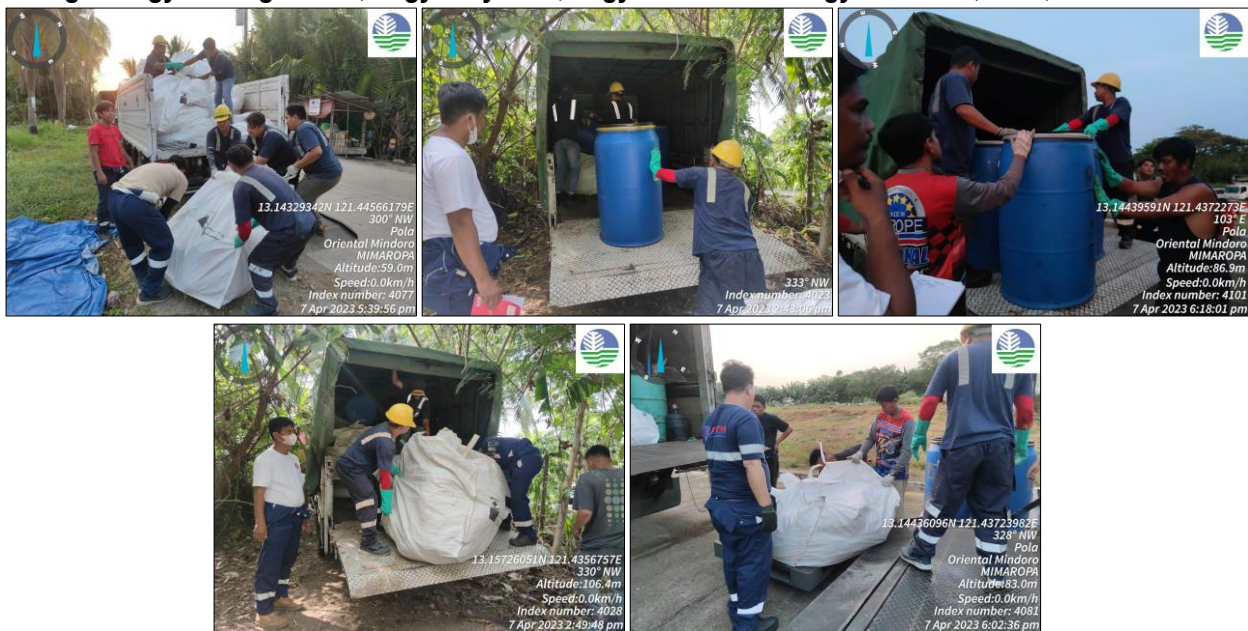
Hauling in Brgy. Puting Cacao, Brgy. Bayanan, Brgy. Calima and Brgy. Batuhan, Pola, Oriental Mindoro

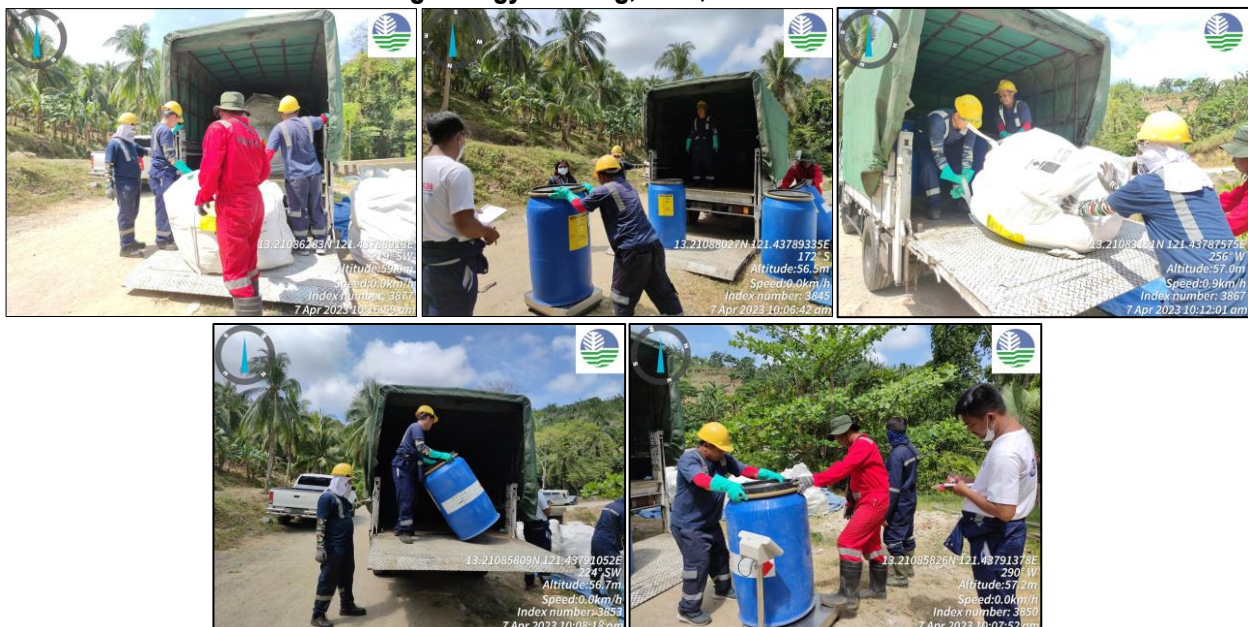
Hauling in Brgy. Misong, Pola, Oriental Mindoro

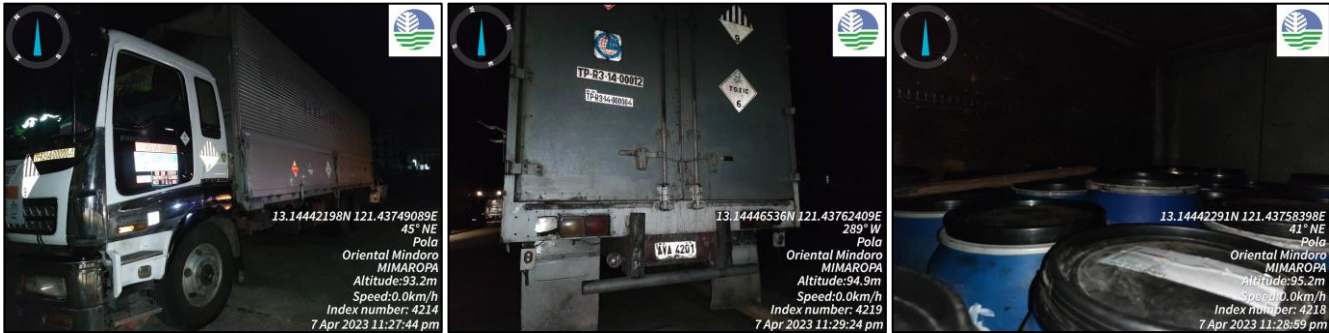
Truck 1

- Genetron International Marketing, hazardous waste transporter, started to haul all the drums and tonner bags in the temporary storage area at Philippine Ports Authority (PPA)-Pola, Oriental Mindoro. The drums containing hazardous waste will be treated by Separ Environmental Corporation located at 600 3rd St., Banaban, Angat, Bulacan.

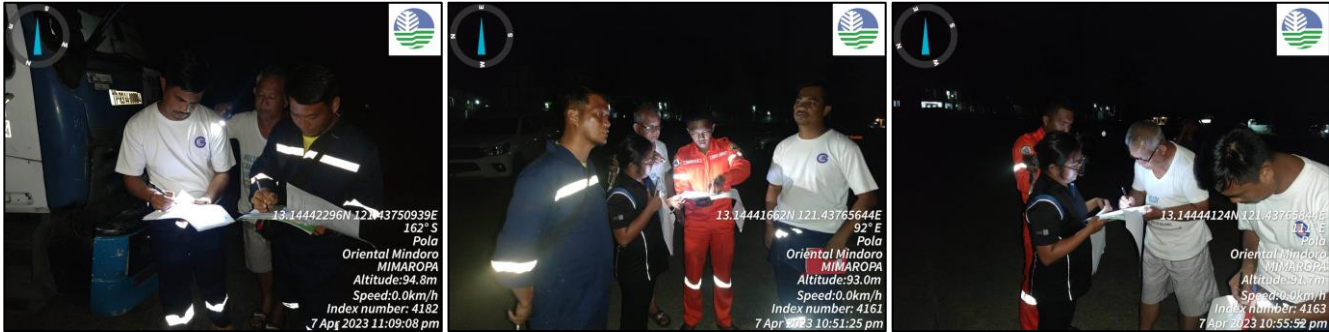
Signing of Manifest Form

Involved parties and witnesses from various agencies participated in the signing of manifest forms for the transport of hazardous wastes from Pola using the 7 wing vans of Genetron International Marketing.

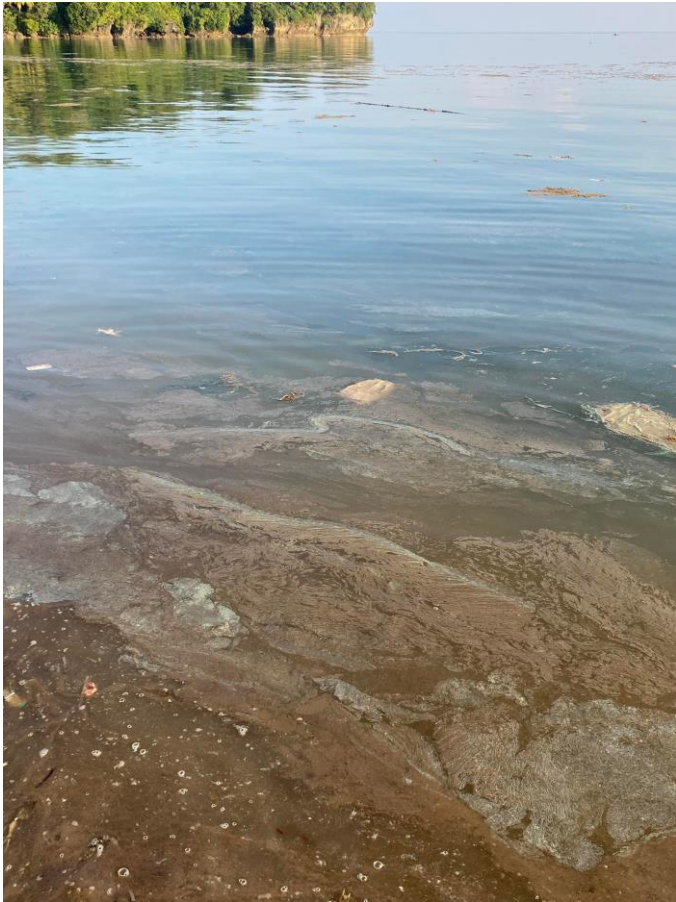
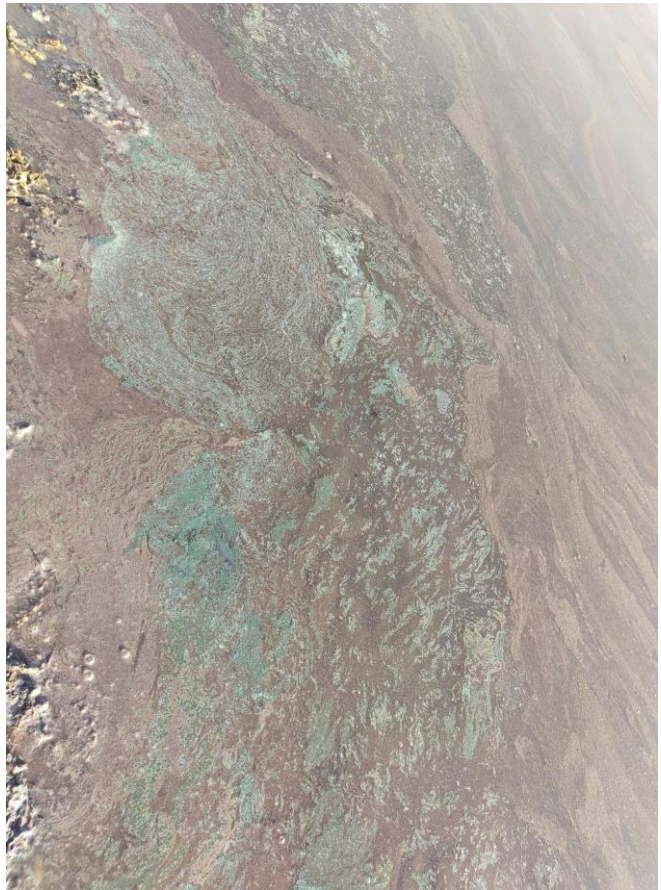
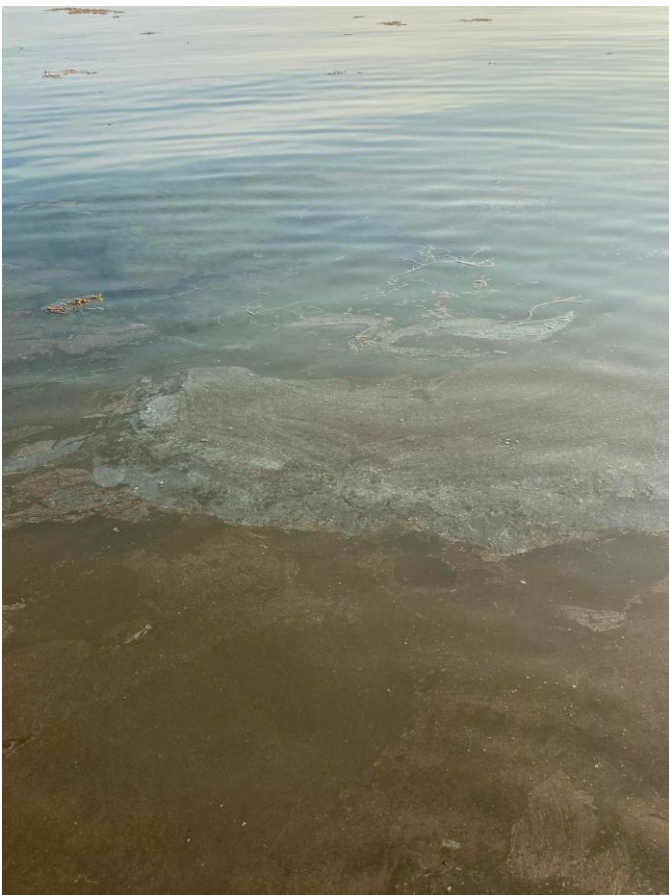
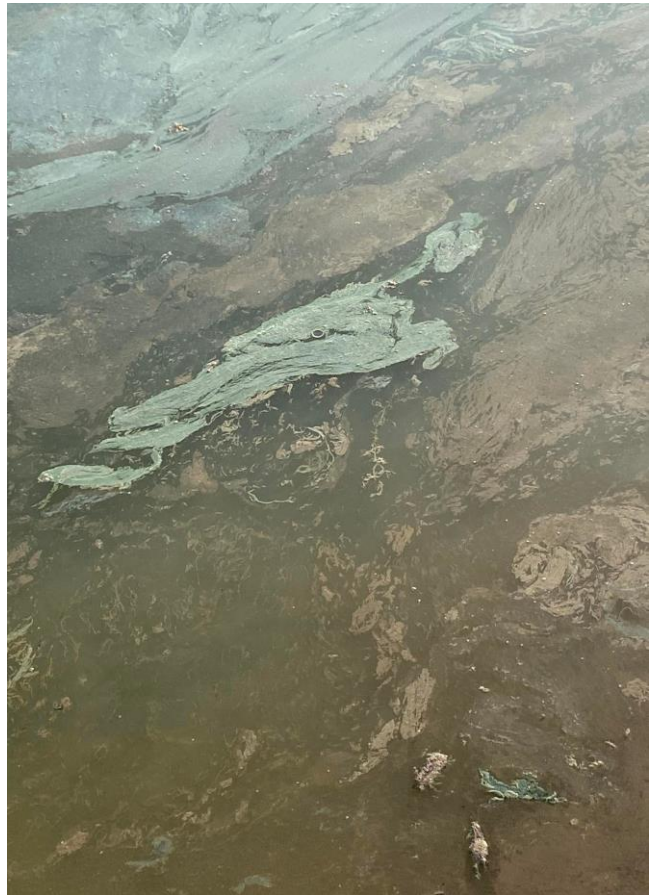
OIL SPILL SIGHTINGS IN ROMBLON, ROMBLON

- Conduct immediate site inspection at Brgys. Agpanabat, Sablayan, and Agnipa in Romblon, Romblon after this Office received reports of alleged sightings of oil spill and oil contaminated materials within the coastline of Brgys. Agpanabat, Sablayan and Agnipa in the Municipality of Romblon, Romblon. It is also important to verify whether the source of this alleged oil spill originated from the sunken MT Princess Empress.
- Coordinate with the Philippine Coast Guard and concerned LGUs for the conduct of clean-up activities and immediate installation of spill booms in all waterbodies potentially affected by the oil spill.
