SUBJECT : **COMPLETE STAFF WORK (CSW) RE: THE REPORTED
ALLEGED ILLEGAL MOUNTAIN QUARRYING BY MR.
EDGARDO TRINIDAD LOCATED AT SITIO
MARAMEGMEG, BARANGAY CORONG-CORONG, EL
NIDO, PALAWAN**

SUBJECT : **COMPLETE STAFF WORK (CSW) RE: THE REPORTED
ALLEGED ILLEGAL MOUNTAIN QUARRYING BY MR.
EDGARDO TRINIDAD LOCATED AT SITIO
MAREMEGMEG, BARANGAY CORONG-CORONG, EL
NIDO, PALAWAN**

PHOTO DOCUMENTATION

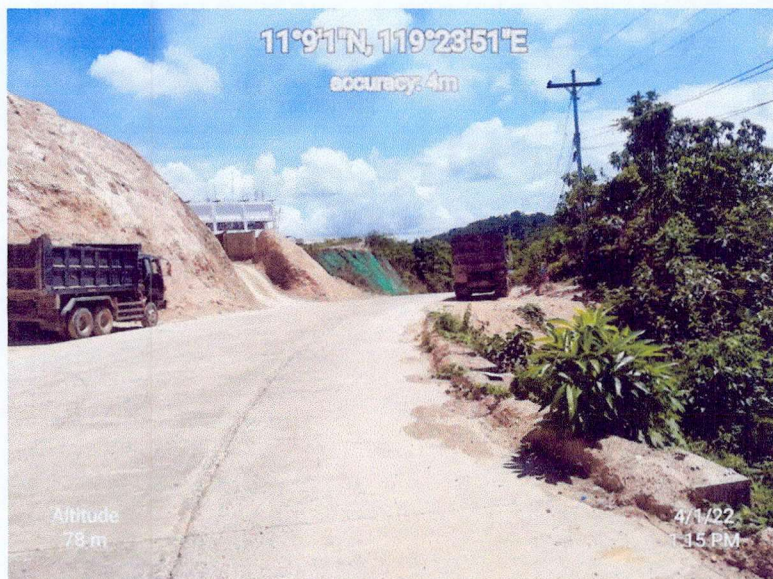
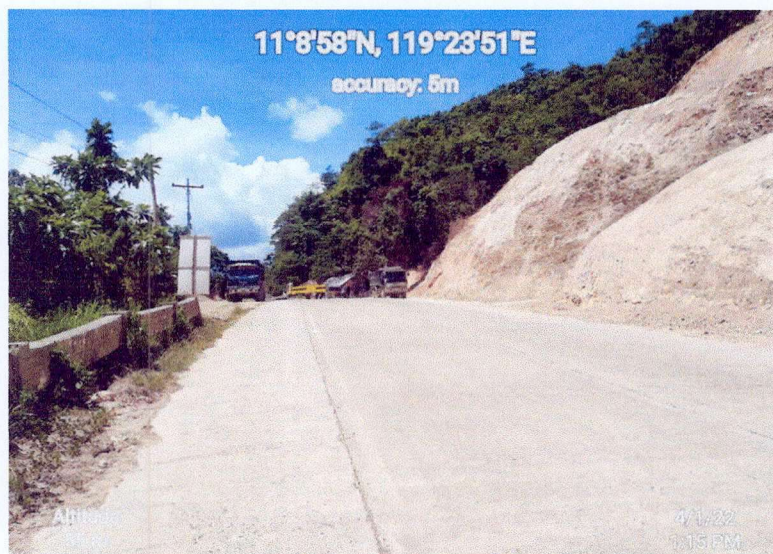
Photo showing that the eroded waste materials located at So. Maremegmeg, Brgy. Corong-corong, El Nido, Palawan was completely removed by Mr. Edgardo Trinidad and the two lanes of national highway is now passable as of April 1, 2022.

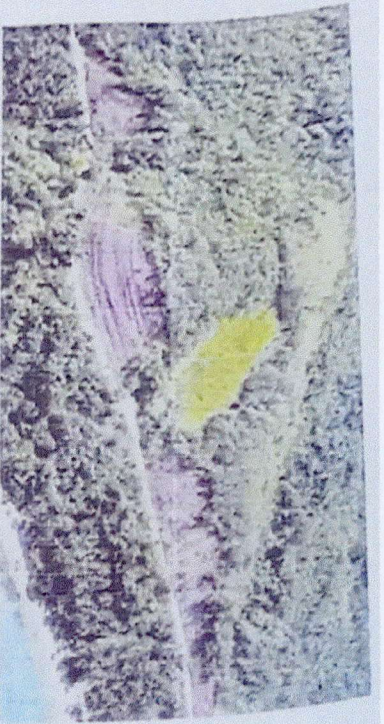
Before

For the past few months we have observed the developments of the property of Mr. Eduardo Trinidad (Bay View Resort). It can be clearly seen from Maremegmeg Beach that his backhoe has been slowly developing a pathway on a hill, and the soil remnants have scattered to the main road and has already eaten up half of it.

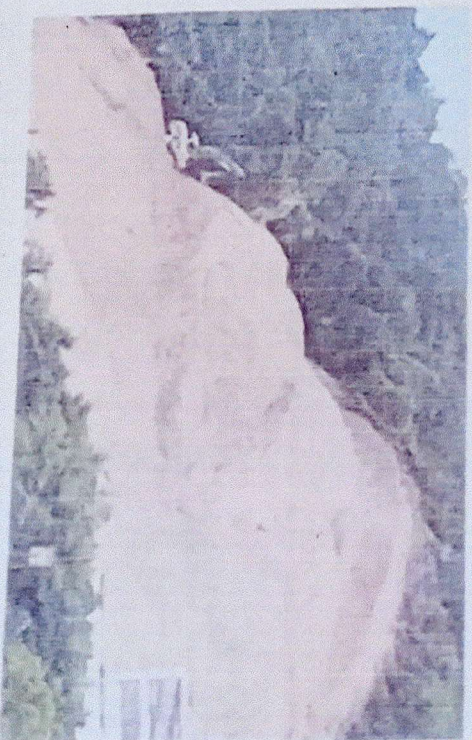
Now

It is of great concern that this should be investigated and addressed immediately. The past typhoon that hit El Nido caused a major landslide and inconvenienced majority of the motorists passing there, because of the thick muddy situation. Some motorists have reportedly slid, citing the landslide as the source of their accident. Aside from that, the soil remnants trickles down to the beach causing murkiness and siltation thus compromising the environment.

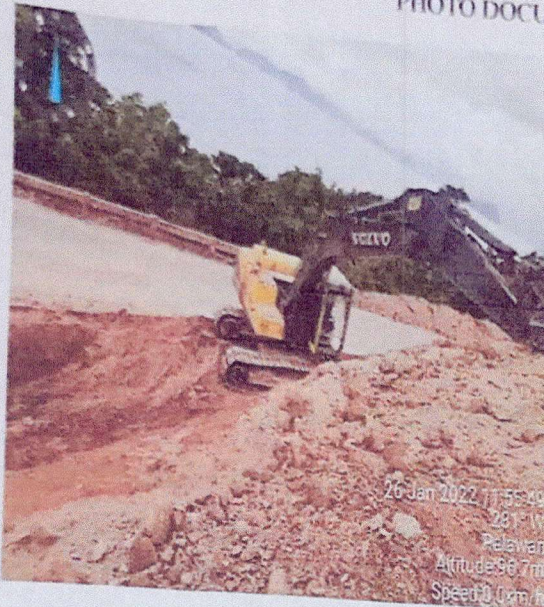
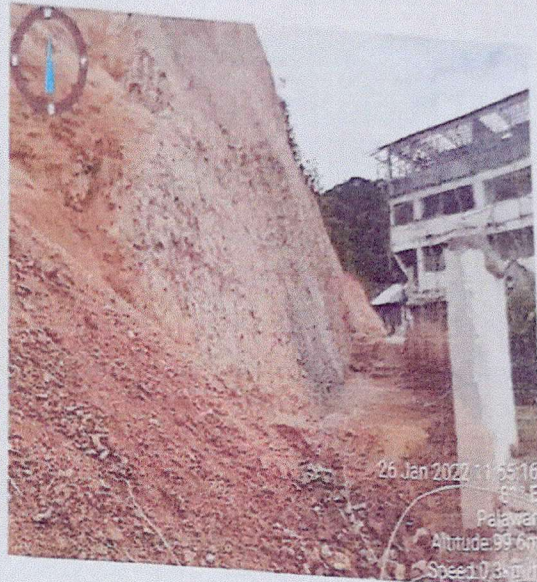
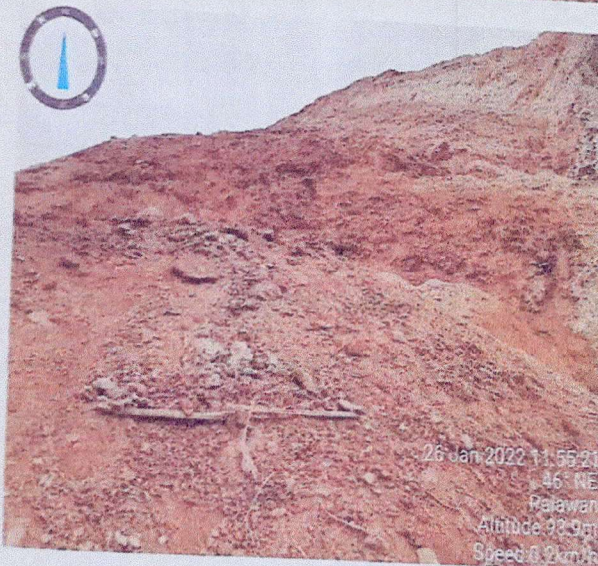
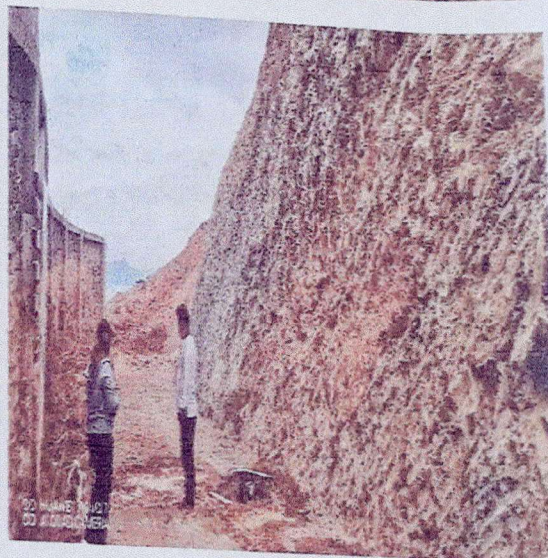
This is to certify that the above photos are correct taken during the inspection and investigation of mountain Quarry own by Mr. Eduardo Trinidad located at Sitio Maremegmeg Barangay Corong El Nido, Palawan.

1. Based on the foregoing field findings, the bedrock is still covered by loose and unconsolidated materials thus, continuous clearing and removal of waste materials is being recommended to avoid continuous downslope movement of loose materials along the road.
2. The "Before and After" photo attached on the email sent by Ms. Brigitte Bustamante is misleading. It was found out that the "Before" photo was the image of the subject area before the landslide occurred on October 2021 and the "After" photo is the recent image when clearing of waste materials and installation of benches are being done.
3. The on-going operation is *not* Mountain Quarry but Slope Stabilization Measure particularly Benching Method since the subject area is classified as Very Highly Susceptible to Landslide. (ANNEX G)
4. Benching is a must in line with ECC Condition No. 4 of the establishment, provides to wit:
