**SUBJECT :** **CORON BAY DEVELOPMENT PROJECT (CBDP): IMPACT  
ASSESSMENT WITH CORRESPONDING MITIGATING  
MEASURES TO THE REMOVAL OF FILLING MATERIALS AND  
INSTALLATION OF CONCRETE SEAWALL**

# CORON BAY DEVELOPMENT PROJECT

IMPACT ASSESSMENT WITH  
CORRESPONDING MITIGATING  
MEASURES TO THE REMOVAL OF  
FILLING MATERIALS AND  
INSTALLATION OF CONCRETE  
SEAWALL

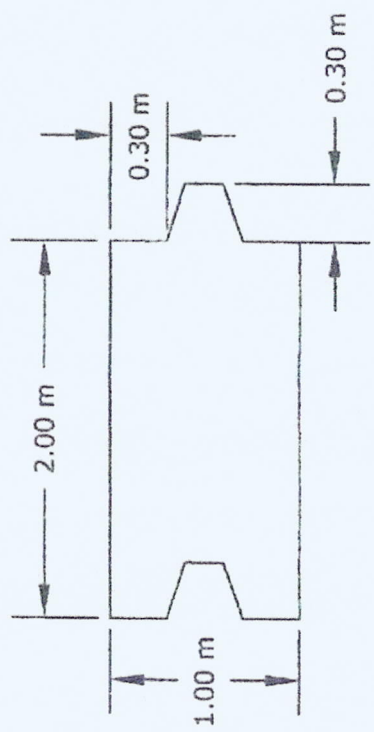
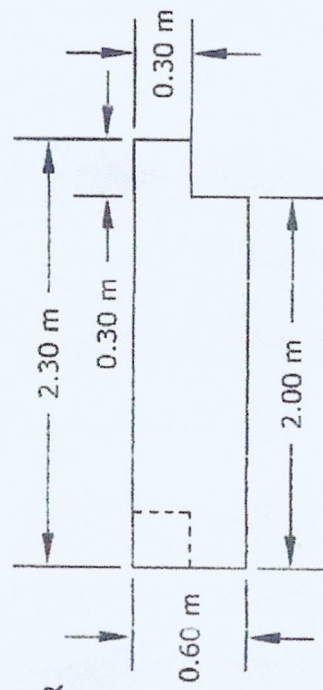
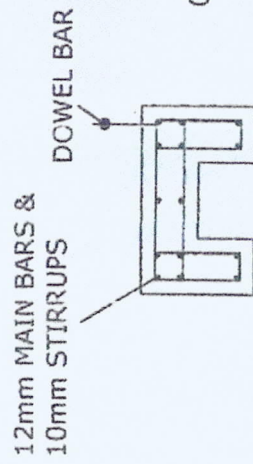
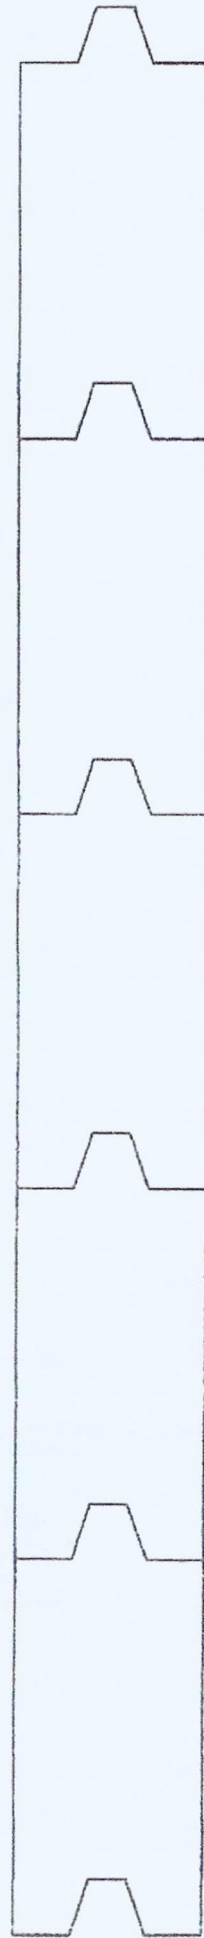
CONCRETE INTERLOCKING BLOCK PLAN

Concrete Seawall is a strong wall or embankment to prevent encroachment of the sea serve as breakwater, etc. This wall will serve also as the permanent boundary of the reclamation.

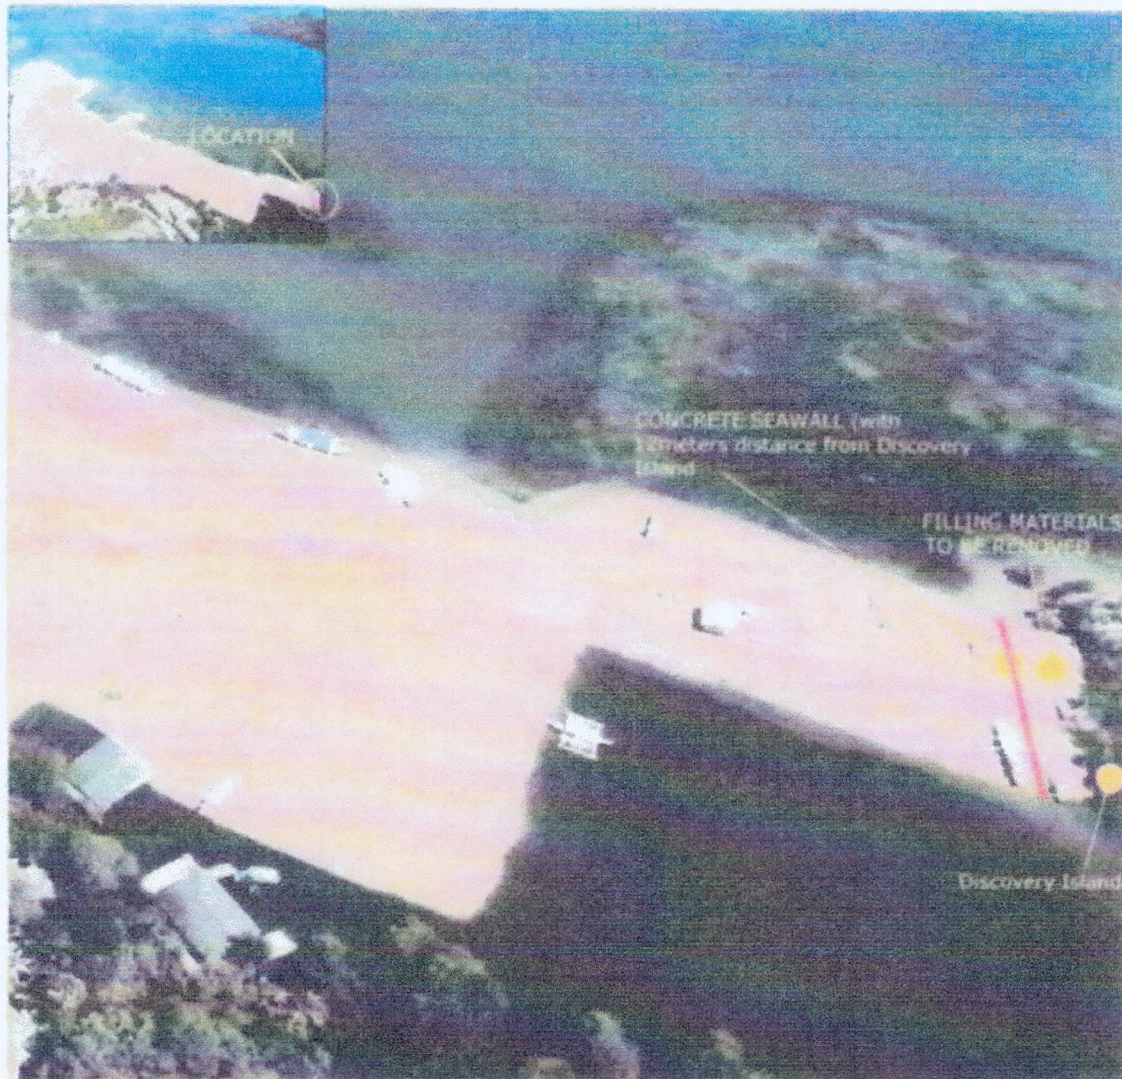
REMOVAL OF EXISTING FILLING MATERIALS BETWEEN  
DISCOVERY ISLAND AND RECLAMATION

Removal/ of Filling Materials is the process of extracting soil which are already reclaimed in the area by the used of heavy equipment's.

Around 12 meters away from the discovery island should be remove or extracted. However, All safety measures and environmental mitigating measures during the activity.
