SUBJECT : REPORT ON THE CONDUCTED MONITORING AND
EVALUATION OF SMALL WATER IMPOUNDING SYSTEM
(SWIS) PROJECT WITHIN THE CBFM AREA SITUATED AT
SO. IBANAG, BRGY. NAIBUAN, SAN JOSE, OCCIDENTAL
MINDORO.

SUBJECT : REPORT ON THE CONDUCTED MONITORING AND
EVALUATION OF SMALL WATER IMPOUNDING SYSTEM
(SWIS) PROJECT WITHIN THE CBFM AREA SITUATED AT
SO. IBANAG, BRGY. NAIBUAN, SAN JOSE, OCC.MDO.

**CONDUCT OF MONITORING AND EVALUATION OF
CONSTRUCTED/INSTALLED SMALL WATER IMPOUNDING SYTEM (SWIS)
WITHIN THE CBFM AREA
AT SO. IBANAG, BRGY. NAIBUAN, SAN JOSE, OCCIDENTAL MINDORO**

Date: March 23, 2023

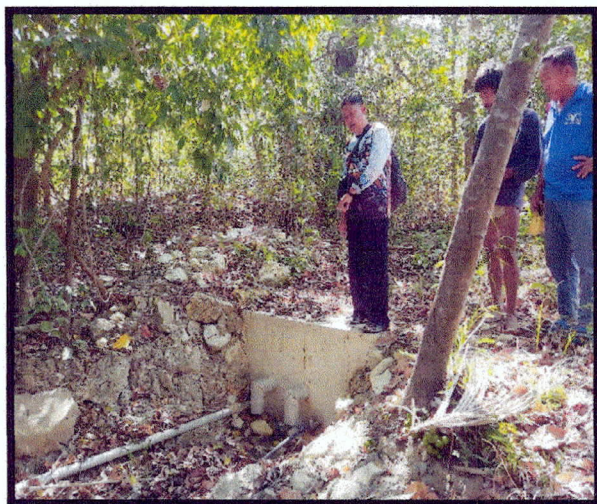
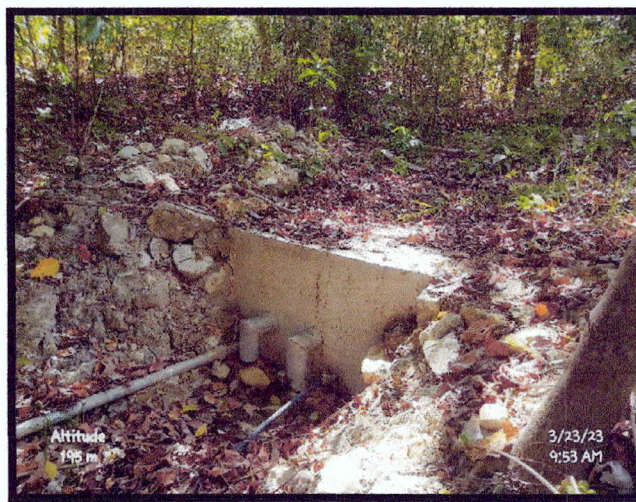
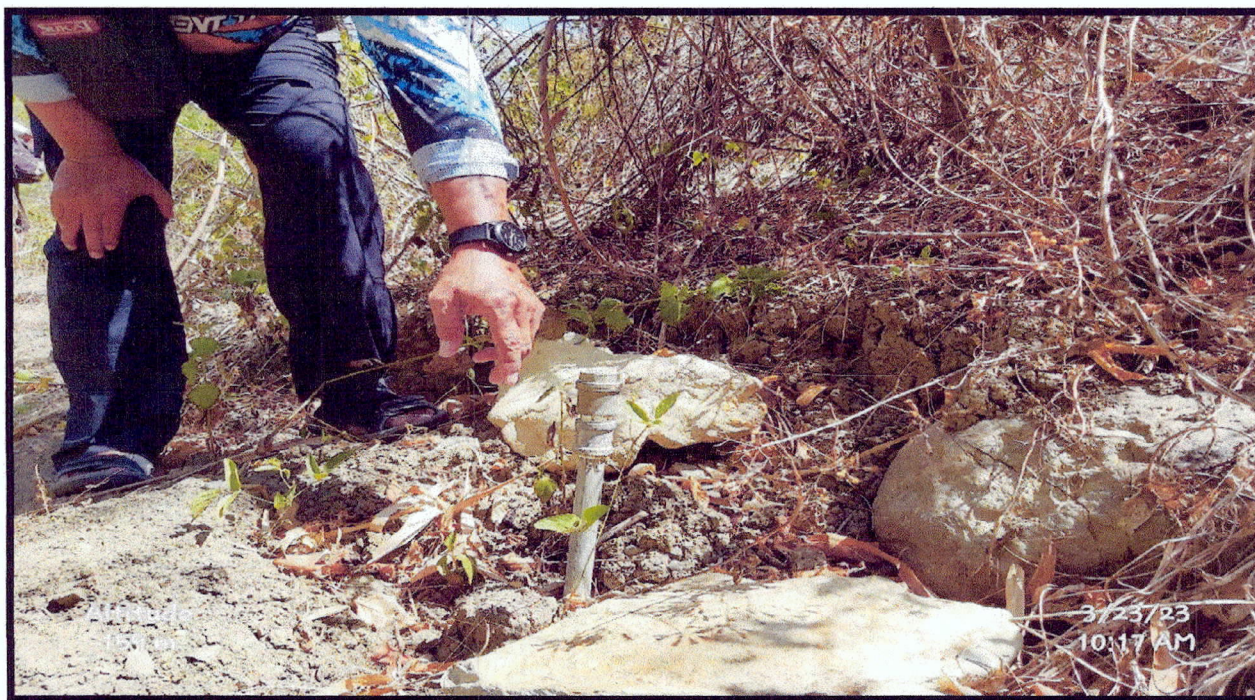
- (1)SWIS Outlet/gate valve and distribution pipe need to be protected.
- (2)Additional Hosts/pipes for water distribution
- (3)Some hosts are expose to sunlight
- (4)Concrete Tank/Source has surrounded by fence.

Geo tagged photos showing the Outlet/gate valve and distribution pipe that needs to be protected

HIGHLIGHTS OF THE MEETING/FGD CENRO San Jose Discussion with People's Organization Regarding the monitoring of SWIS March 23, 2023 So. Ibanag, Brgy. Naibuan, San Jose, Occ. Mdo.		
STATUS/FINDINGS	DISCUSSION/ RECOMMENDATION	REMARKS/PO COMMITMENTS
SWIS Outlet/gate valves and distribution pipe need to be protected	Engr. Malco Lamigo representative from from Regional Office reiterated the importance of the outlet. Hence, he recommends that it should be protected by installing fence. In order for it not to be damaged by any human/animals activities. As well as the distribution pipe must have cover for protection	People's Organization led by PO Chairperson Yato Elias said that, the recommendations mentioned by Engr. Lamigo needs financial consideration since (we) PO don't have a fund. But we agreed to Sir Lamigo, said by Yaton Elias. Thus we (PO) commit to do our best to comply the relayed matters. Agreement as follows: <ol style="list-style-type: none"> 1. PO members including the PO Official commit to pay contribution in order for them to have savings. 2. Also, they commit to establish nursery within the area for additional income generating.

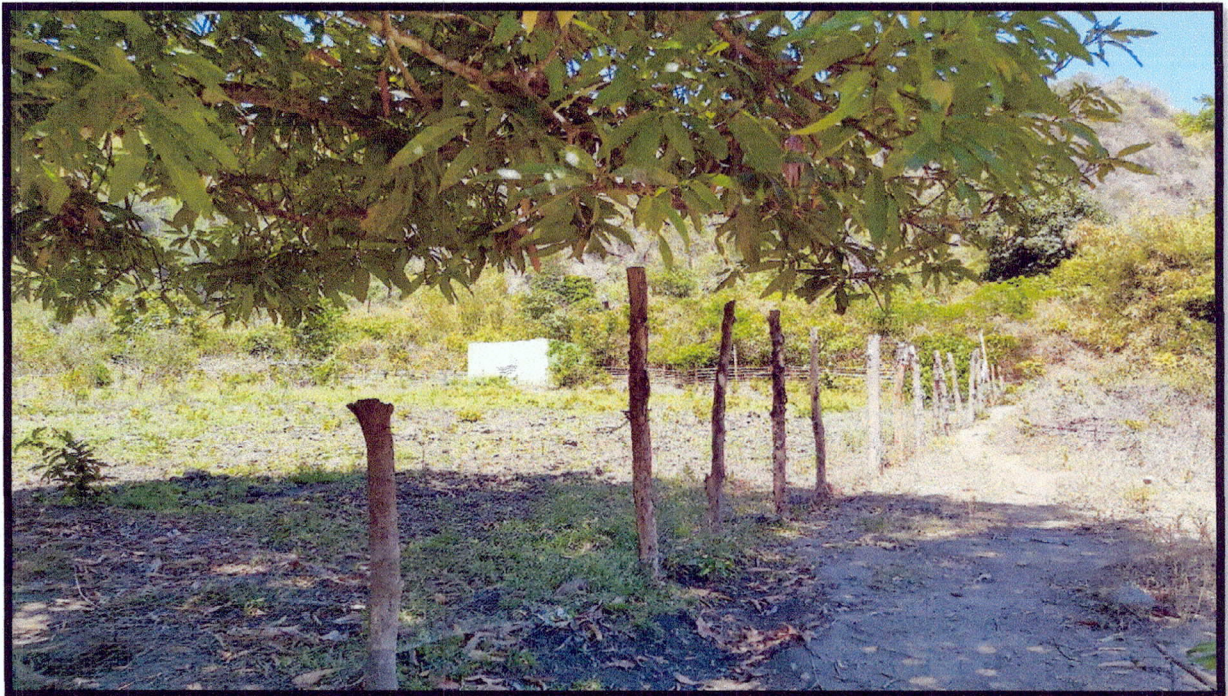
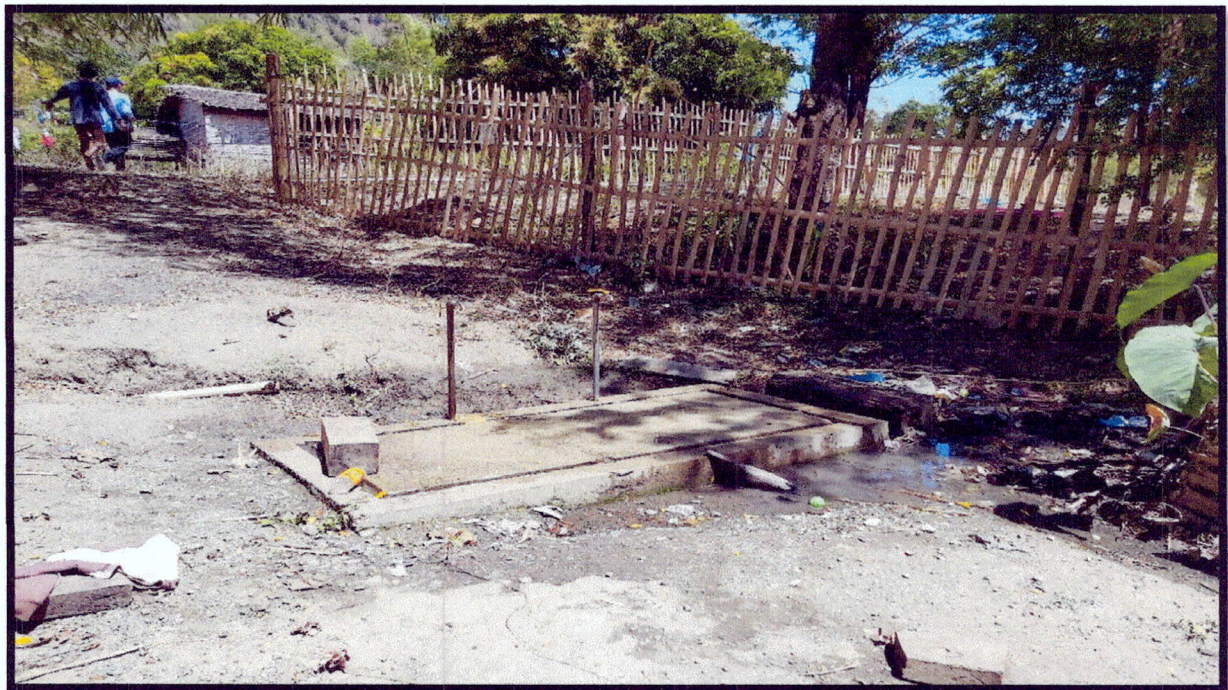
Geo tagged photos showing the SWIS/Concrete tank/source surrounded by fence

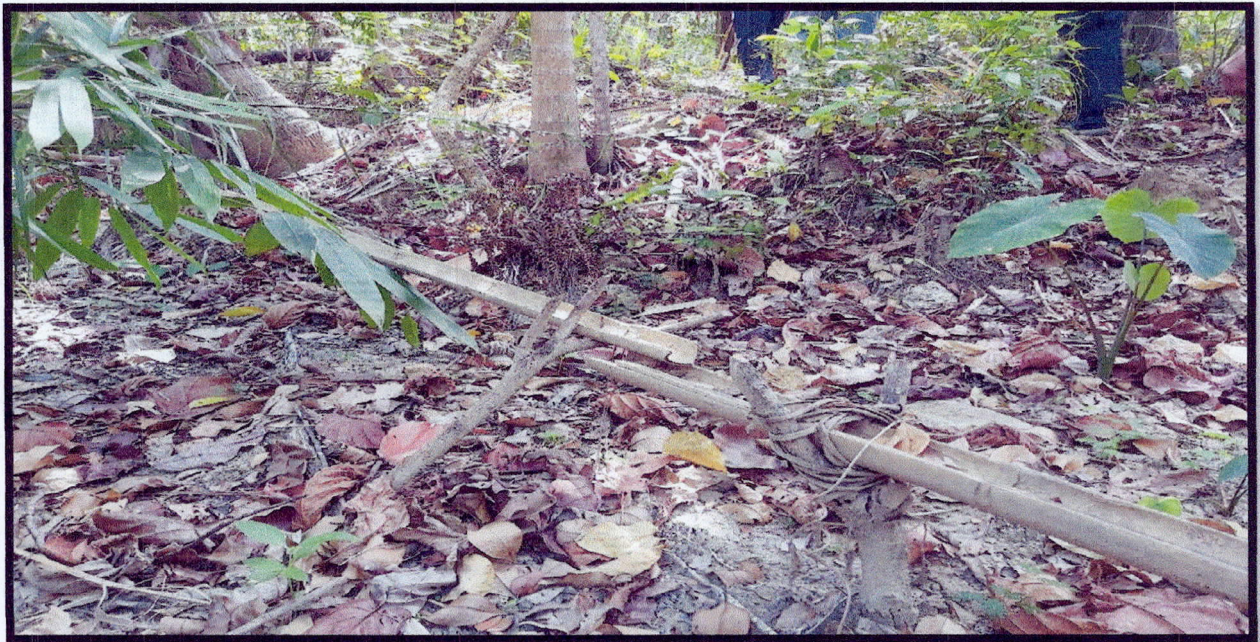
Photo showing the old-time water ways of the community that produce insufficient water supply

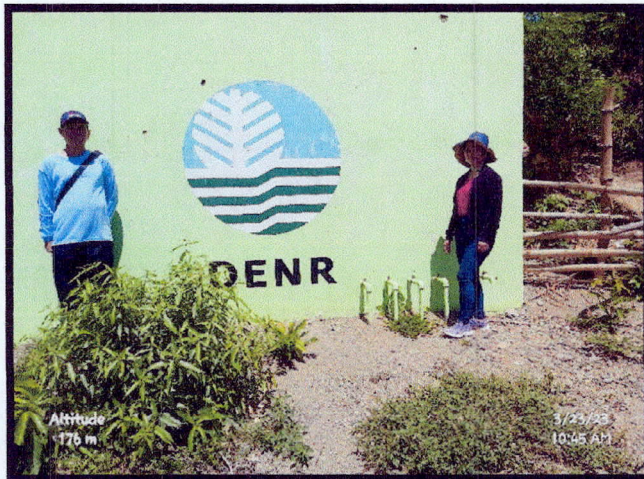
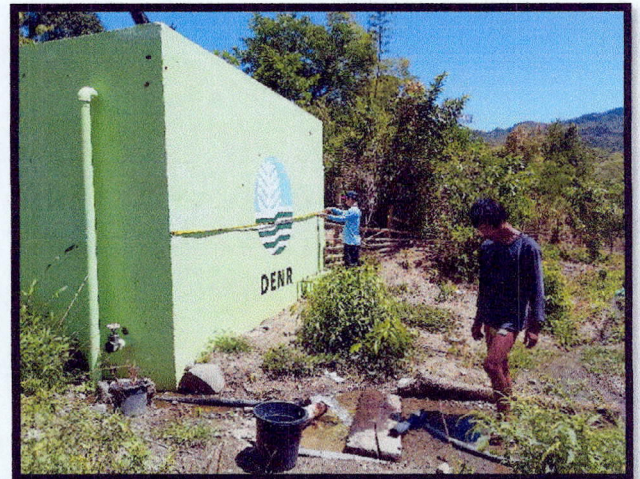
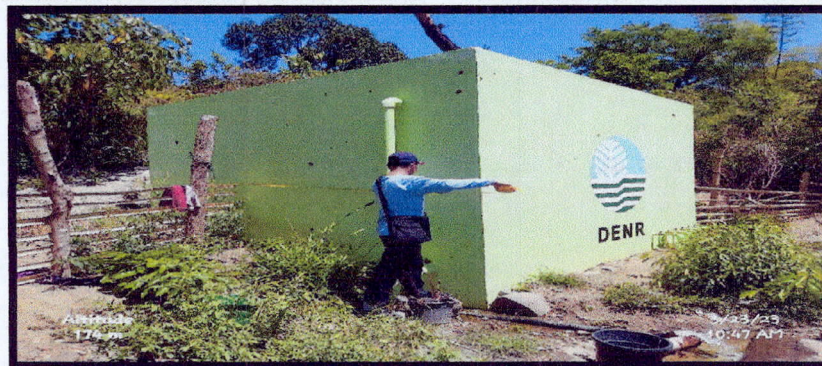
Photo showing the SWIS constructed/installed within the CBFM area of Ibanag Multipurpose Cooperative, Inc. situated at So. Ibanag, Brgy. Naibuan, San Jose, Occ. Mdo. One of the development within the area that addressed the insufficient water supply in the community
