REPORT ON **FOREST** LAND USE MONITORING FOR **TOURISM PURPOSES** (FLAGT) AGREEMENT AWARDED TO MR. ROLAND F. RODRIGUEZ LOCATED AT ARENA ISLAND, BRGY. PANACAN, NARRA, PALAWAN

MONITORING REPORT ON FOREST LAND USE AGREEMENT FOR

TOURISM PURPOSES (FLAgT) AWARDED TO MR. ROLAND F. RODRIGUEZ LOCATED AT ARENA ISLAND, BGY. PANACAN,

GEOTAGGED PICTURES TAKEN DURING THE COMPLIANCE MONITORING DATED MAY 16, 2023 OF AWARDED FLAgT TO ARENA ISLAND

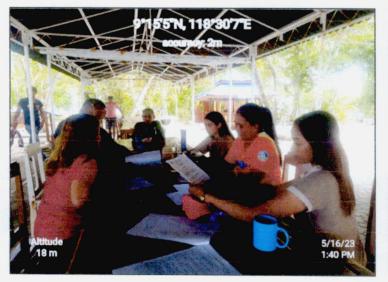
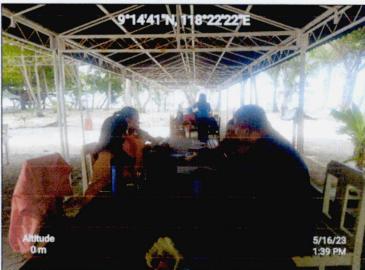
Geotagged pictures above show the Compliance Monitoring Team discussing the purpose and process of monitoring. (Entry Conference)

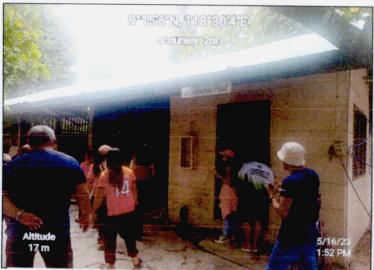
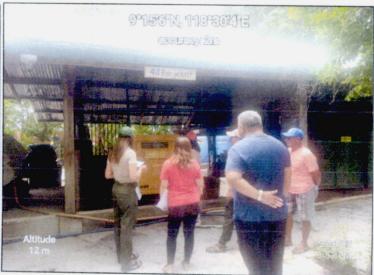
Genset

3. Compliant to RA 8749, Clean Air Act of 1999 /DAO 2000-81		/	The resort is already processing the Permit to Operate for their gensets.
4. Compliant to RA 9003, Ecological Solid Waste Management Act of 2000/DAO 2001-34	/

- The Holder must secure necessary permits such as discharge permit, permit
 to operate and alike and strictly adhere on the terms and conditions stipulated
 in the ECC;
- To formally inform this Office thru letter the change of the management due to the passing away of the Holder Roland F. Rodriguez together with the death certificate and the last will and testament stating the transfer of rights as to the management of the island;
- To submit Annual Report as required under Article XIX of the agreement;
- The Holder must apply for the accreditation of the resort for the hazardous waste generator;

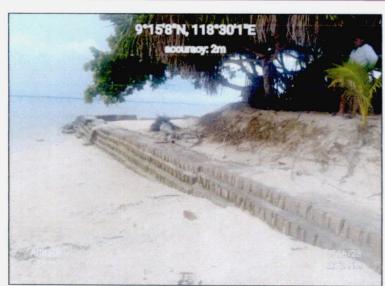
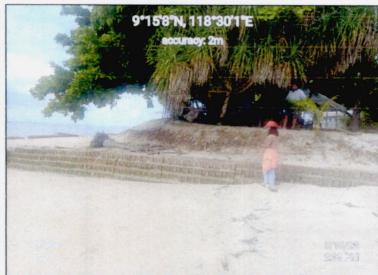
Water Breaks

- g. They planted two hundred (200) coconut seedlings within the island:
- h. That, the breakwater built within the island were destroyed due to bad weather and coastal erosion;

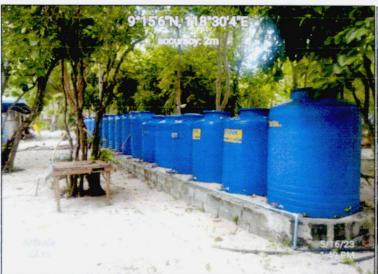
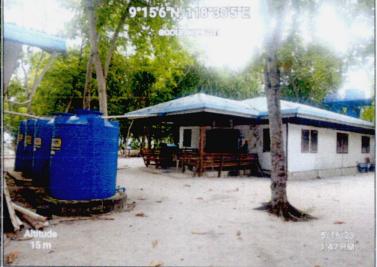
Rainwater Collector Tanks

- The Holder installed 49 pieces of plastic water tanks as rain collector in all casitas and staff houses, the rain water collected was processed through a purifying machine;
- In addition to the installed rain collector, the resort is also using the desalination process to obtain water for domestic use only and drinking/purified water were bought from mainland Narra, Palawan;
- The Holder planted additional two (200) seedlings of coconut within the island;
- The Holder implemented the trash in and trash out strategy for their guests;
- The Holder puts fence guard with label on the nesting sites of Marine Turtles; and,
- Though Arena Island Beach Resort is not yet in its usual operation due to pandemic, the management has long been keeping the volume of tourists/visitors manageable and within the carrying capacity of the island.

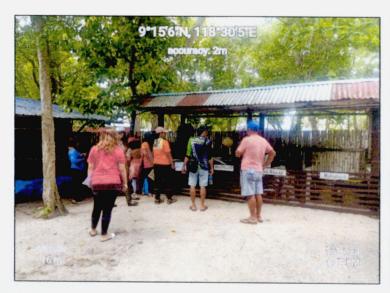
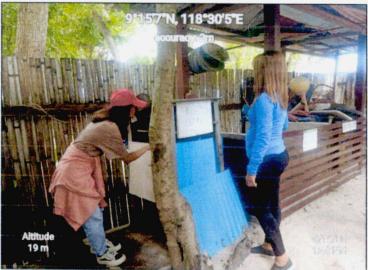
Materials Recovery Facility

- f. That, their Material Recovery Facility (MRF) has already visible labels and they already built separate compartment for the hazardous wastes as it is recommended during the last year compliance monitoring;
