SUBJECT : **ACCOMPLISHMENT REPORT ON WATER QUALITY
MONITORING WITHIN PROCLAIMED NIPAS PROTECTED
AREA UNDER MARINE PROTECTED AREA
STRENGTHENING AND NETWORKING OF EL NIDO
MANAGED RESOURCE PROTECTED AREA (ENMRPA) FOR
MARCH CY 2023**

SUBJECT : **REPORT ON WATER QUALITY MONITORING WITHIN PROCLAIMED NIPAS PROTECTED AREA UNDER MARINE PROTECTED AREA STRENGTHENING AND NETWORKING OF EL NIDO MANAGED RESOURCE PROTECTED AREA (ENTMRPA) FOR MONTH OF FEBRUARY CY 2023**

PHOTO DOCUMENTATION

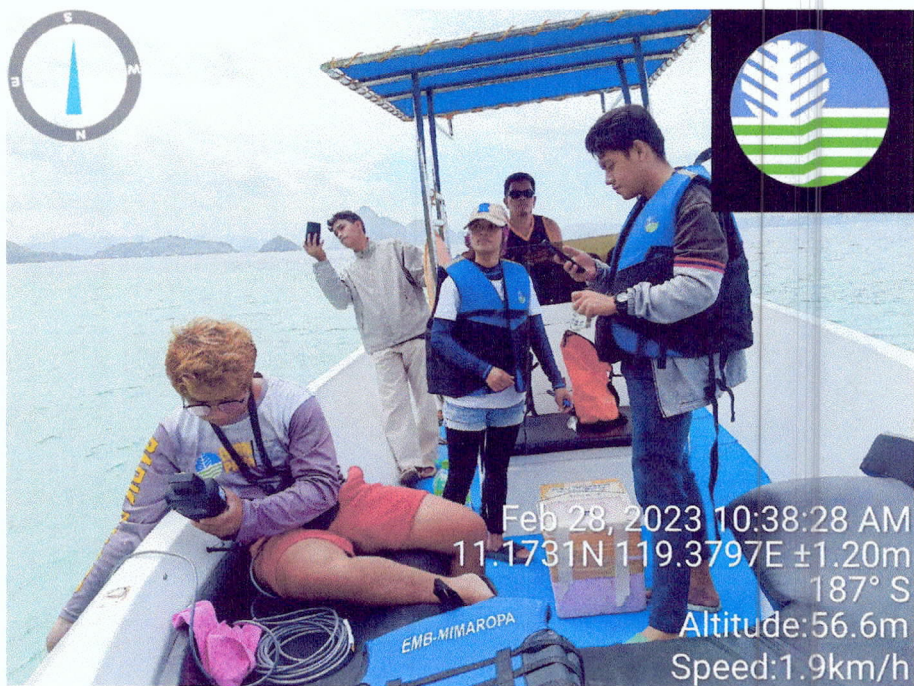
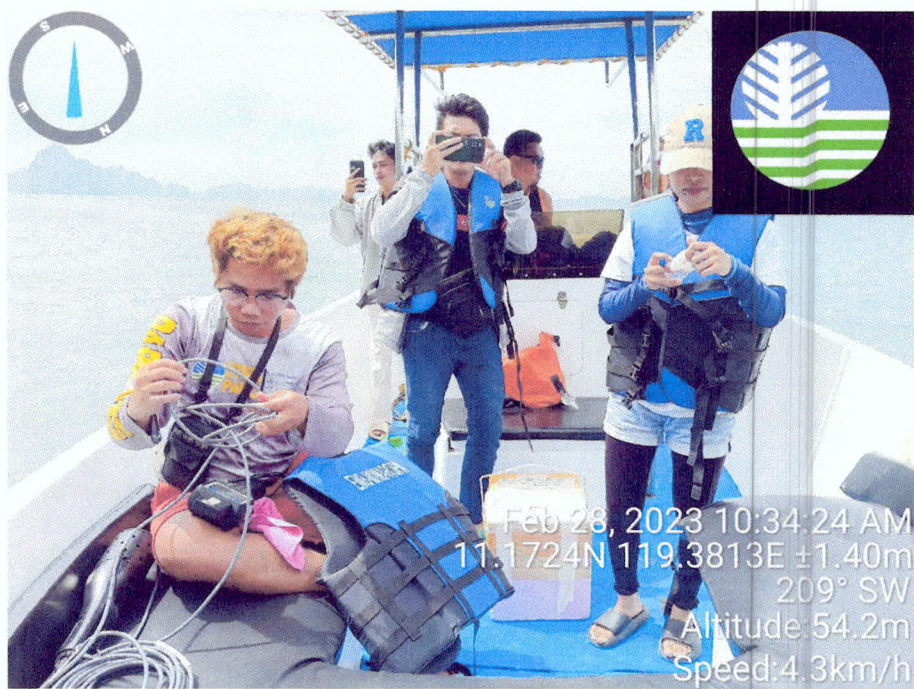
This is to certify that the above photos were true and correct and taken during the Water Qulaity Monitoring activity of ENMRPA for the month of February 2023.

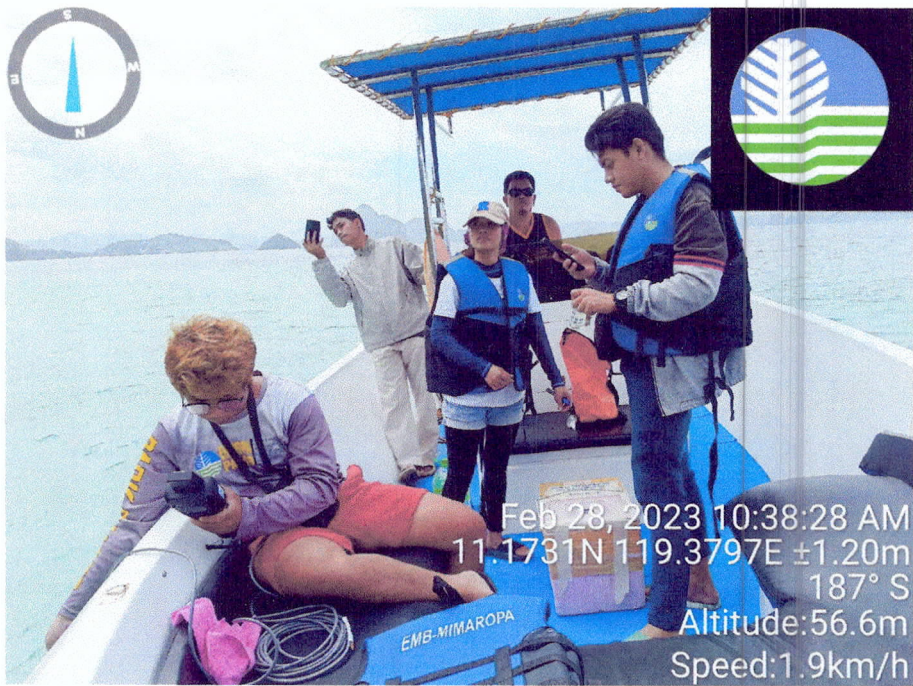
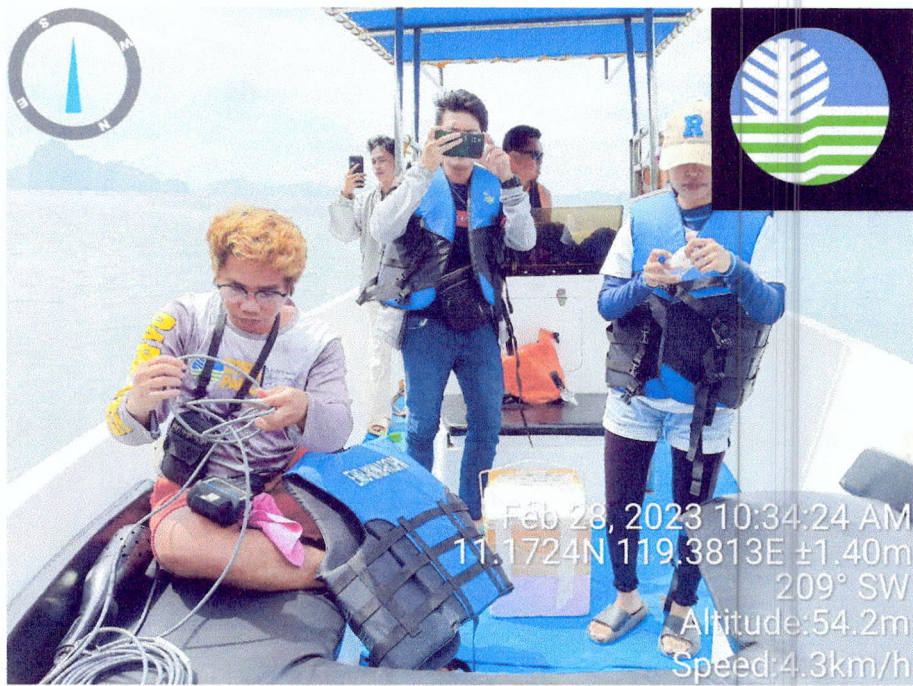
PHOTO DOCUMENTATION

This is to certify that the above photos were true and correct and taken during the Water Quality Monitoring activity of ENMRPA for the month of February 2023.

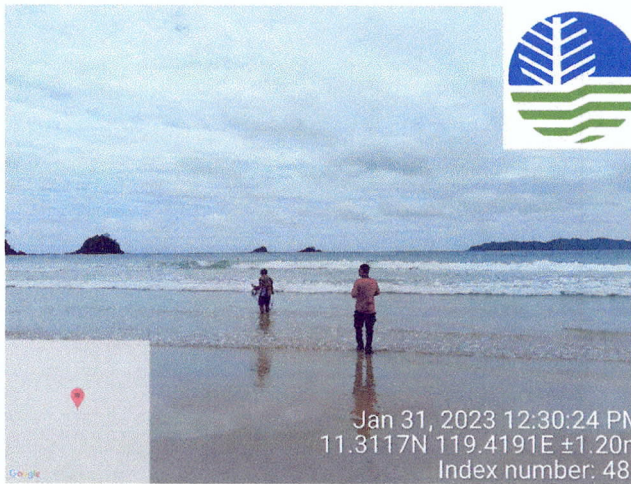
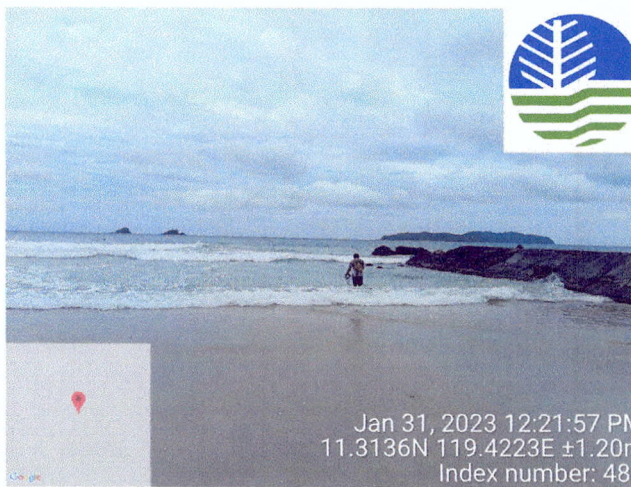
PHOTO DOCUMENTATION

This is to certify that the above photos were true and correct and taken during the Water Qulaity Monitoring activity of ENTMRPA for the month of January 2023.
